RoseKennedyGreenway.org

CAPITAL REPAIRS REPORT

Summer 2015

CAPITAL REPAIRS INVENTORY

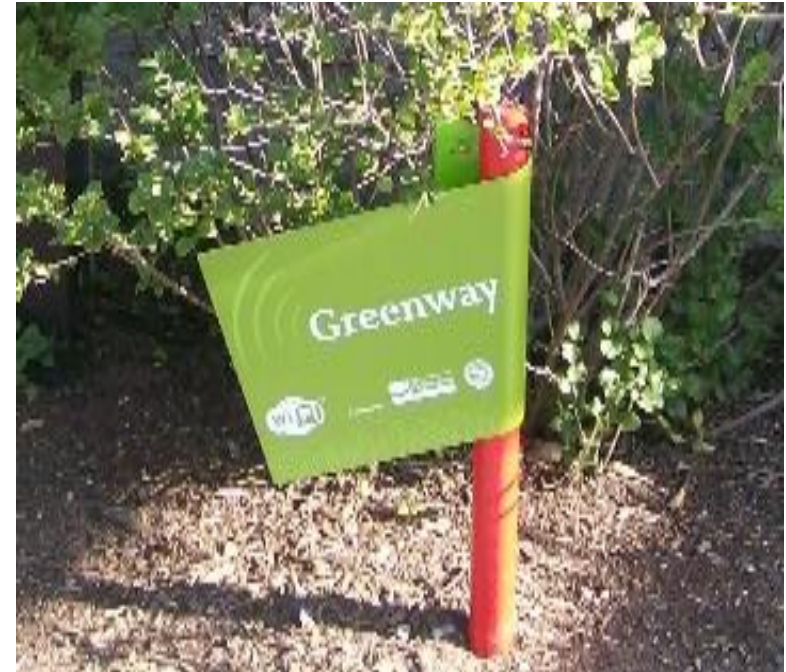
GREENWAY WIFI

Normal Deterioration

- **Details:**
 - Poor connectivity due to an outdated wifi system
- **Repair Option:**
 - Upgrade wifi system
- **Cost Estimate:** \$100,000 – 200,000

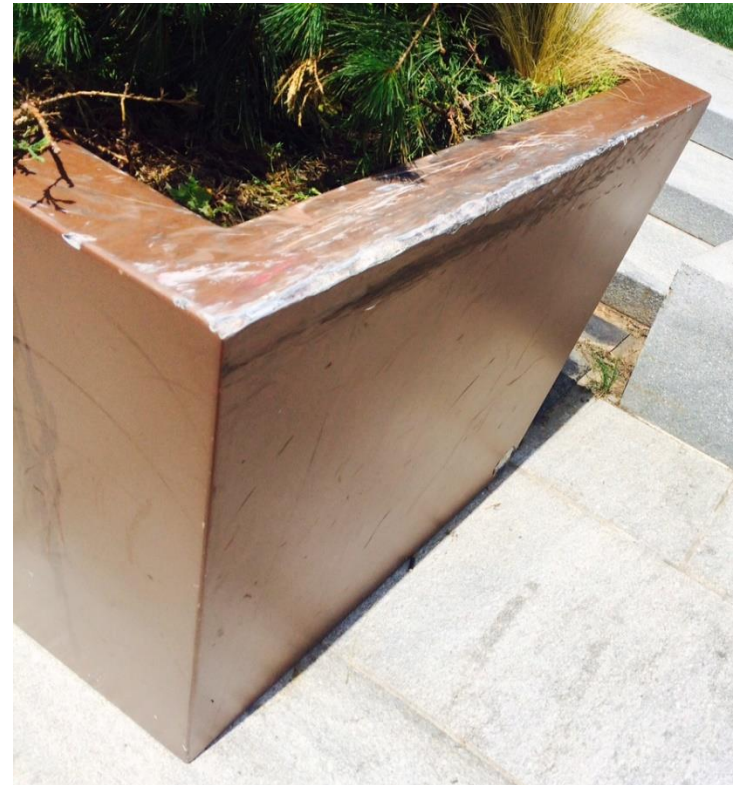
HORTICULTURE CONTAINERS

Accident/Vandalism

- **Details:**
 - Damage primarily incurred as a result of vandalism/accidents
 - Approximately a dozen containers of various size and style, located across the park, will need attention
 - This problem presents an aesthetic issue
- **Repair Option:**
 - Replacement for severe damage; possible in-house repairs to lesser damaged containers
- **Cost Estimate:** \$7,500 – 10,000

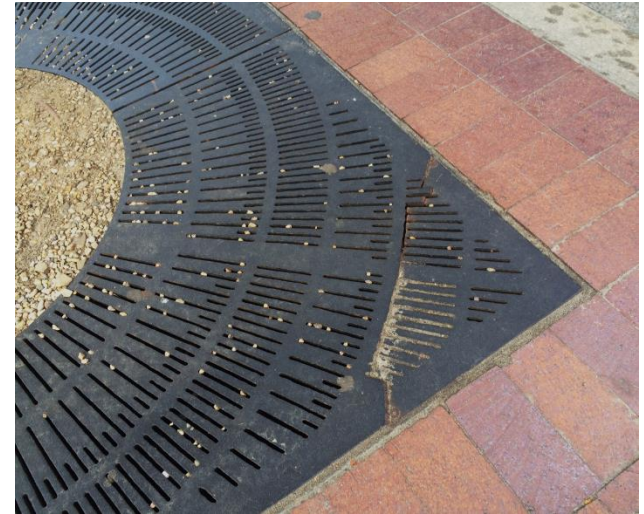
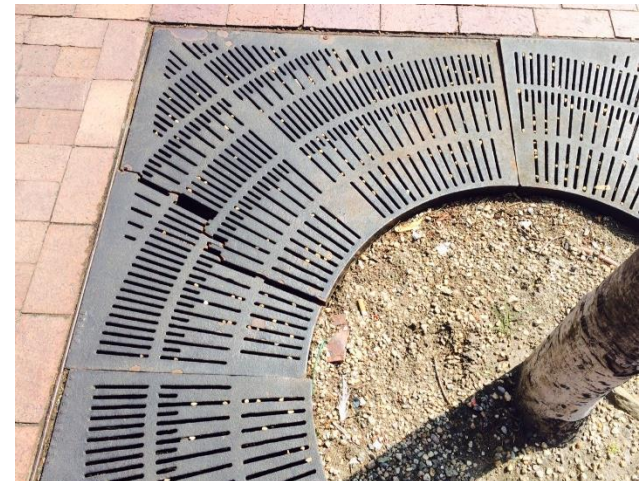
TREE GRATES

Normal Deterioration

- **Details:**
 - 5 tree grates throughout the park are broken in some capacity
 - This problem presents an aesthetic issue, negatively impacts park maintenance and is a safety hazard
- **Repair Option:**
 - Welding repair required on some; others need complete replacement
 - In-house
- **Cost Estimate:** \$5,000 – 7,500

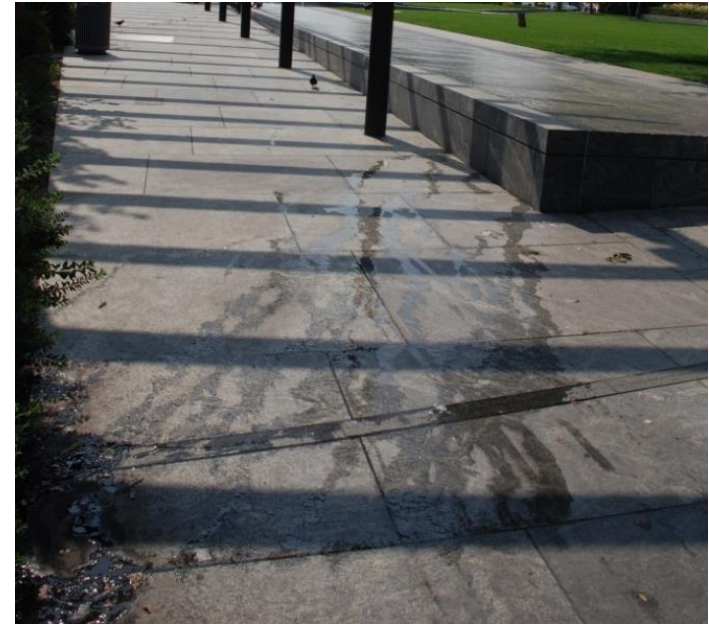
CHANNEL FOUNTAIN LEAK

Design/Install Flaw

- Water leaking along multiple points of fountain wall joint due to failure of joint sealant
- If not repaired before winter, moisture behind wall will freeze, increasing likelihood of structural damage
- This item is carried over from 2014, and is in the process of being fixed, but there remains more work to be completed
- This problem presents an aesthetic issue, and will continue to deteriorate, increasing repair cost

- Replace joint sealant and install backer rod in wall cap above water line
- In-house repair

- **Cost Estimate:** \$7,000 – 10,000

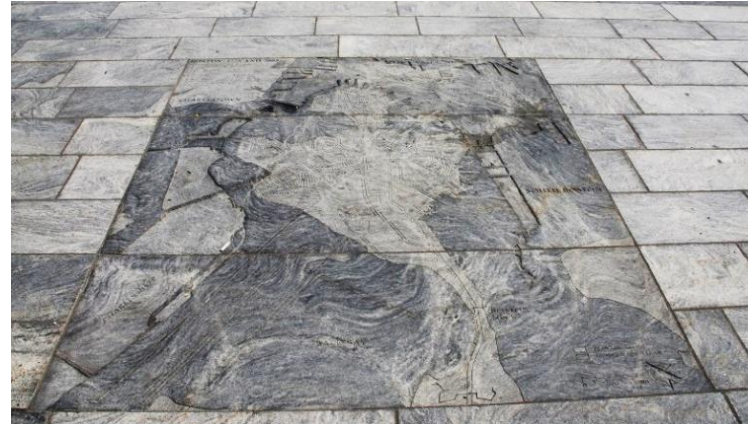
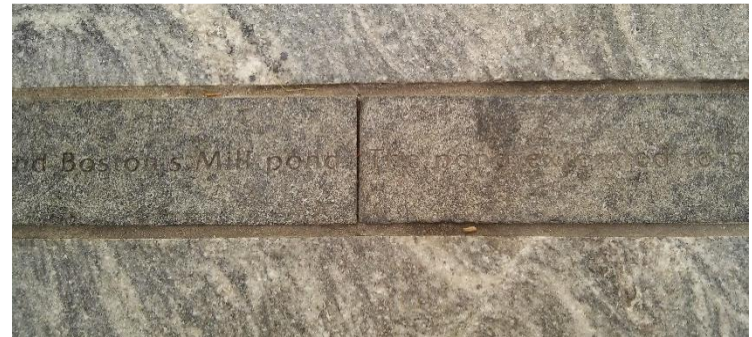
NORTH END ENGRAVINGS FADING & DAMAGE

Normal Deterioration

- **Details:**
 - Details of historical map on southwest corner are wearing and chipping
 - Engraving near the northeast corner of the park is fading
 - This problem presents aesthetic issues
- **Repair Options:**
 - Repair damaged map features and paint with lithichrome paint
 - In house repair or contract out
- **Cost Estimates:** \$2,500 – 5,000

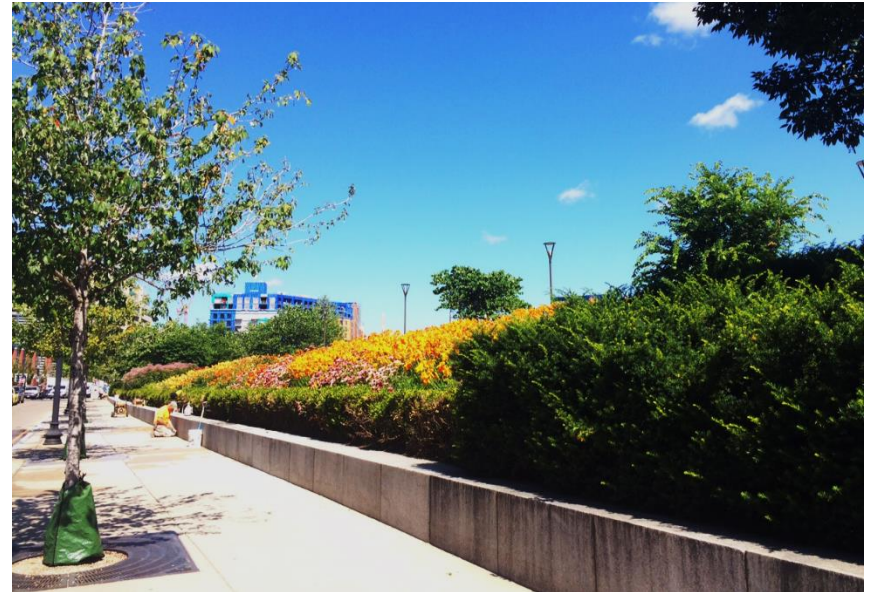
BOXWOOD RENOVATIONS

Design/Install Flaw

- **Details:**
 - There is an invasive weed and the boxwoods were installed too close together
 - A more dynamic landscape is desired on the Surface Artery side of Parcel 10 that would increase plant variety and year round seasonal interest
 - Renovations would mimic the new boxwood design on Parcel 8, which was installed the summer of 2015
 - This problem presents aesthetic issues and negatively impacts park operations

- **Repair Option:**
 - Horticulture and irrigation costs
 - Contract out
- **Cost Estimate:** \$175,000 – 225,000

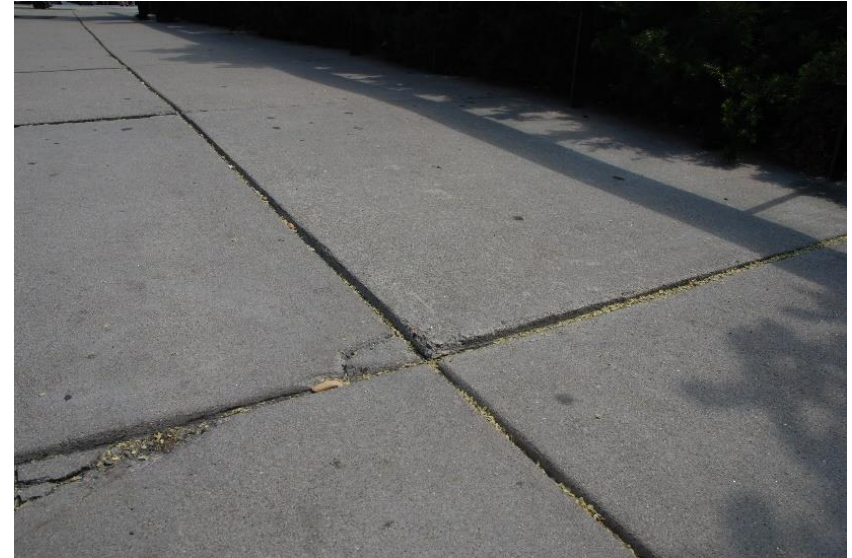
SIDEWALK SLABS BUCKLING

Normal Deterioration

- **Details:**
 - Sidewalk slabs have heaved due to tunnel vibrations and frost damage
 - Problem worsens in winter; sidewalk is not ADA compliant
 - Construction area is approximately 12'x16' adjacent to Hanover St on the north side of Parcel 10
 - This problem concerns a basic park amenity

- **Repair Option:**
 - Remove and reset slabs; re-grade surface below
 - Contract out
- **Cost Estimate:** \$5,000 – 10,000

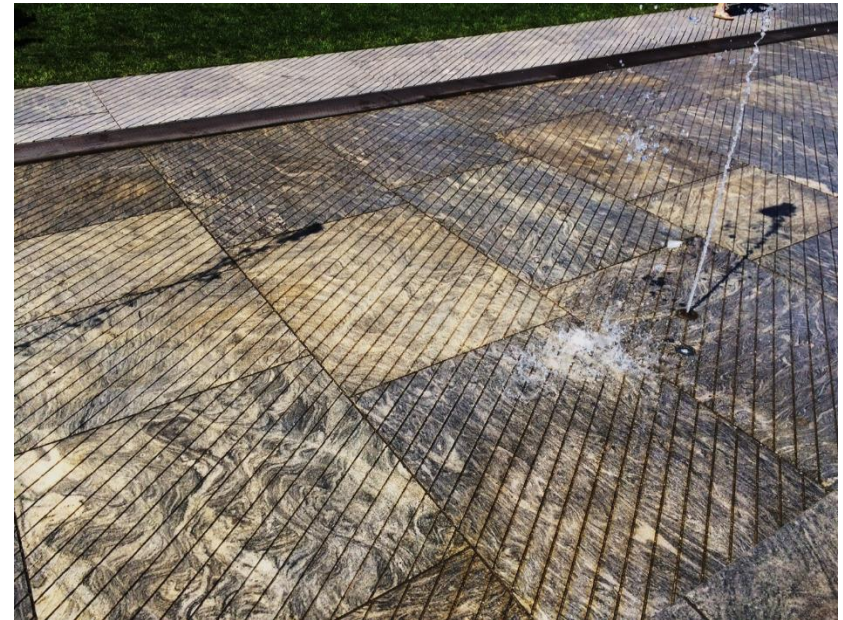
RESET STONE SLABS IN FOUNTAIN

Normal Deterioration

- **Details:**
 - 6 slabs in the fountain need to be reset, as they have heaved
 - Water enters joints, and when it freezes the slabs are disturbed, creating trip hazards
 - This problem is an aesthetic issue, concerns a basic park amenity, and is a safety issue
- **Repair Option:**
 - Contract out work
- **Cost Estimate:** \$10,000 – 12,000

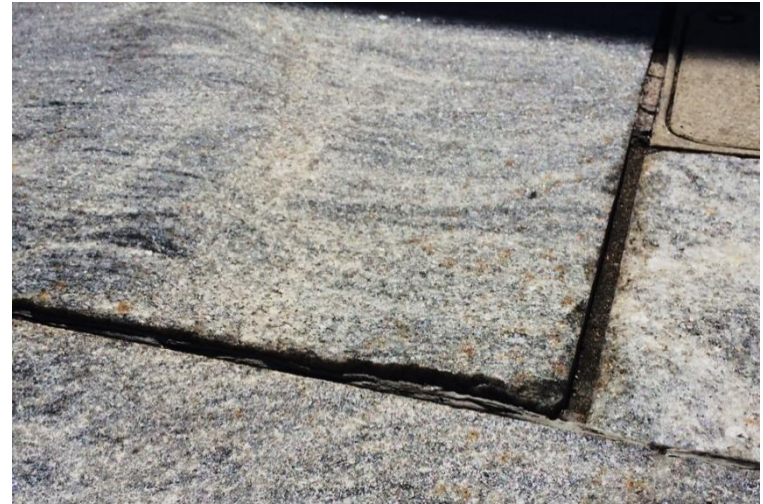
RESET GRANITE SLABS

Normal Deterioration

- **Details:**
 - 30 slabs need to be reset, the slabs have heaved
 - Water enters joints, and when it freezes the slabs are disturbed, creating trip hazards
 - This problem is an aesthetic issue, concerns a basic park amenity, and is a safety issue
- **Repair Option:**
 - Contract- out
- **Cost Estimate:** \$12,000 – 16,000

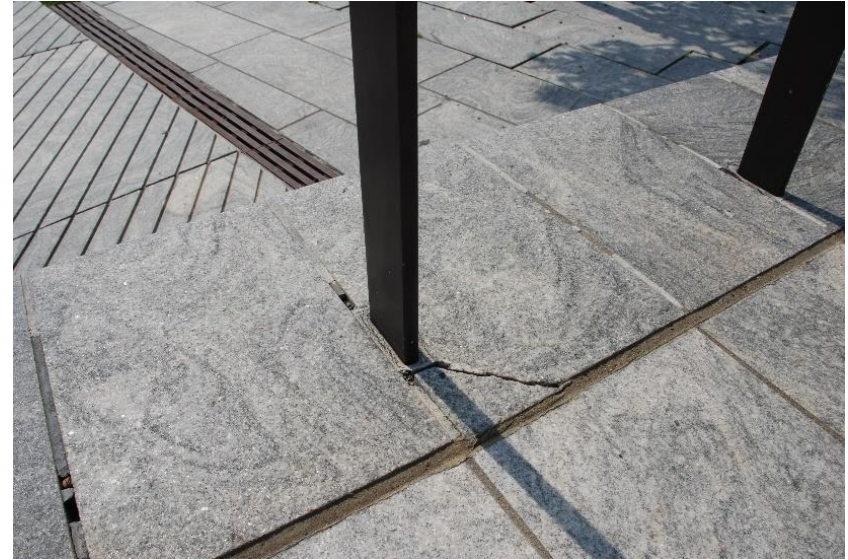
STONE WALL CAPS & GRANITE PAVERS CRACKING

Design/Install Flaw

- The bases of the fountain railings were not installed properly allowing moisture to seep through the spaces between the stones
- Freezing conditions put stress on the joints, causing stone caps and adjacent granite pavers to crack
- All of the caps need to be reset, some replaced, but those on the north side of Parcel 10 and south side of Parcel 8 are priorities
- This problem continues to deteriorate; repair costs may rise

- Remove stone cappings and reset, re-cut or replace as necessary; replace any broken pavers
- In-house repair or contract out

- **Cost Estimate:** \$20,000 – 30,000

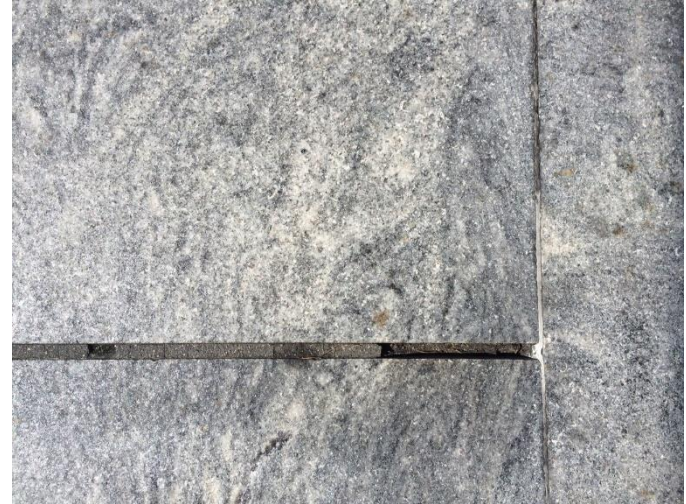
RE-GROUT FOR JOINT ISSUES

Normal Deterioration

- **Details:**
 - Joints need to be re-grouted due to normal deterioration
 - If not done, water enters joint, freezes and causes pavers to heave upwards
 - Amount of work is beyond the capacity of the Greenway team
 - This problem presents an aesthetic issue, will continue to deteriorate and increase repair cost, and negatively impacts park operations

- **Repair Option:**
 - Re-grout joints where grouting has deteriorated with flexible sealant
 - Contract out
- **Cost Estimate:** \$50,000 – 55,000

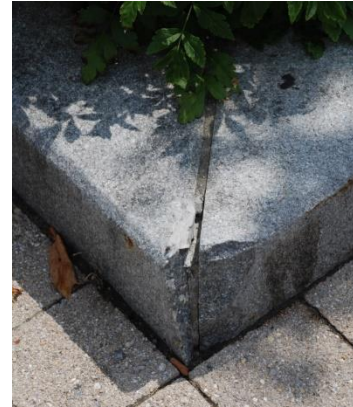
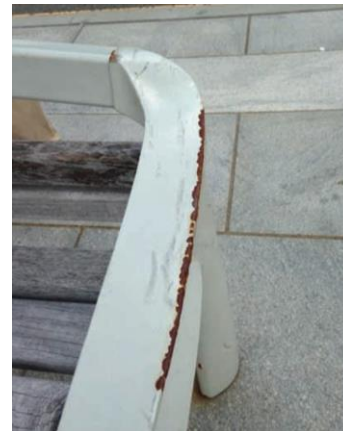
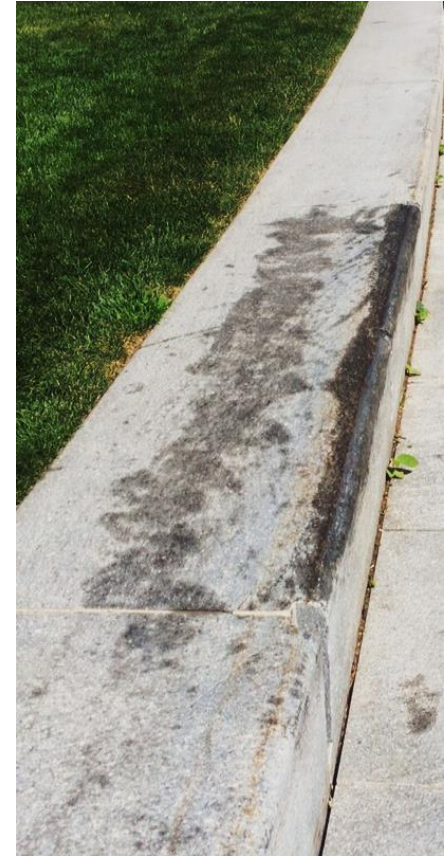
SKATEBOARD DAMAGE

Accident/Vandalism

- Skateboards are damaging the granite, benches and planters by applying wax and using the features to skate on
- Previous deterrents are not working; next remedy attempt will increase the frequency of deterrents
- This problem concerns a park amenity and will continue to deteriorate, increasing repair costs

- Increase number of deterrents; repair damaged areas
- Contract out

- **Cost Estimate:** \$15,000 – 25,000

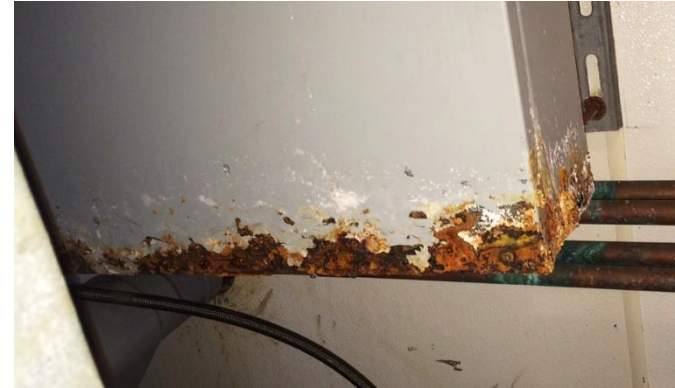
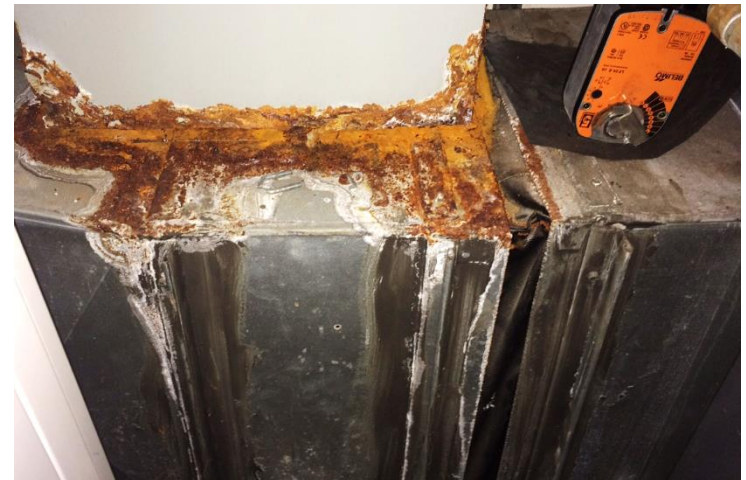
RINGS FOUNTAIN: LEAK INTO VAULT A/C DUCTS

Design/Install Flaw & Cause Unknown

- In the vault there are (future-use) empty conduits that seem to be leaking water
- Water is causing metal cabinet to rust
- This problem will continue to deteriorate, increasing repair cost

Photos show damage caused by leak

- Find water source, seal duct from water penetration

- **Cost Estimate:** \$15,000 – 50,000

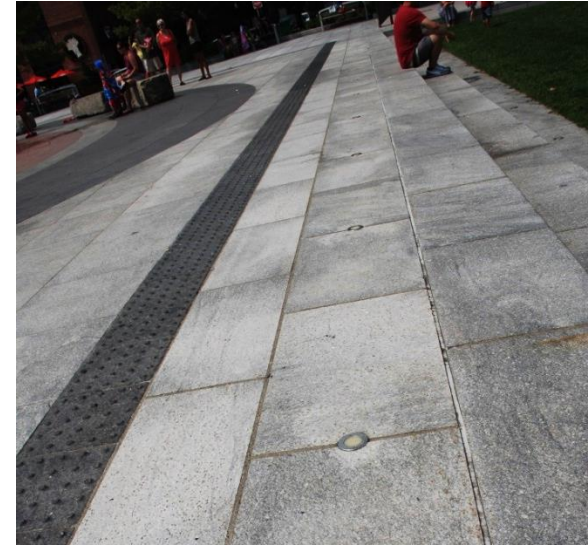
RINGS FOUNTAIN STEP LIGHTS MALFUNCTION

Design/Install Flaw

- All of the 29 lights embedded in the steps adjacent to the Rings Fountain do not function; condensation has built up inside some of the fixtures
- The lights are part of the original site design and contribute to the park's visual appeal; they also have a safety function
- The original lights are no longer manufactured
- This problem presents aesthetic issues and concerns a basic park amenity

- Select alternative lights and retrofit the step light settings

- **Cost Estimate:** \$20,000 – 30,000

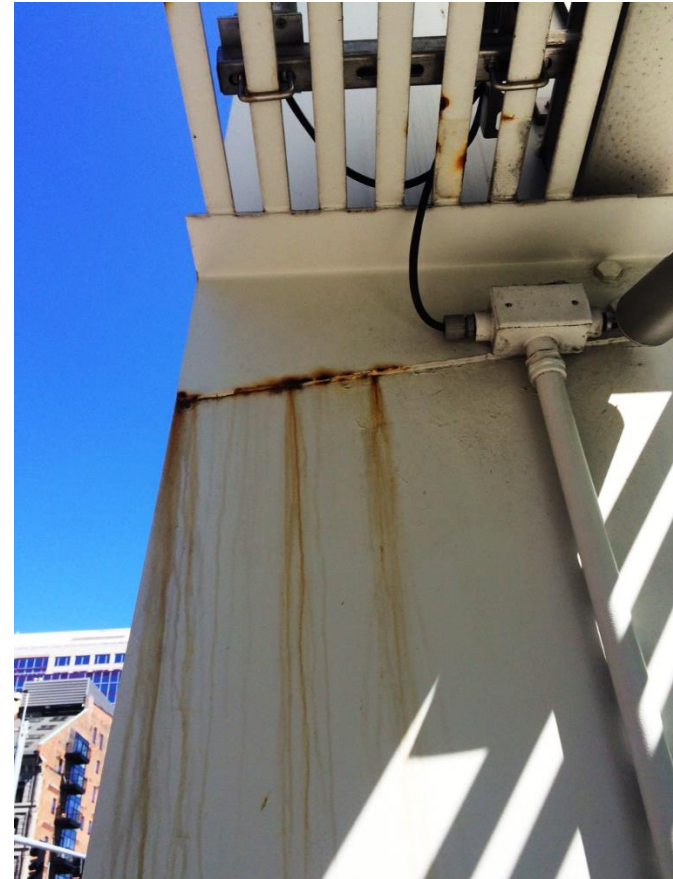
LIGHT BLADES REPAINT

Normal Deterioration

- **Details:**
 - The light blades on Parcels 15 & 16 contain 12 structures
 - They need to be repainted periodically due to scratches, damage or normal wear and tear of the elements
 - This problem presents an aesthetic issue
- **Repair Option:**
 - Repaint the 12 structures
 - Contract out
- **Cost Estimate:** \$15,000 – 20,000

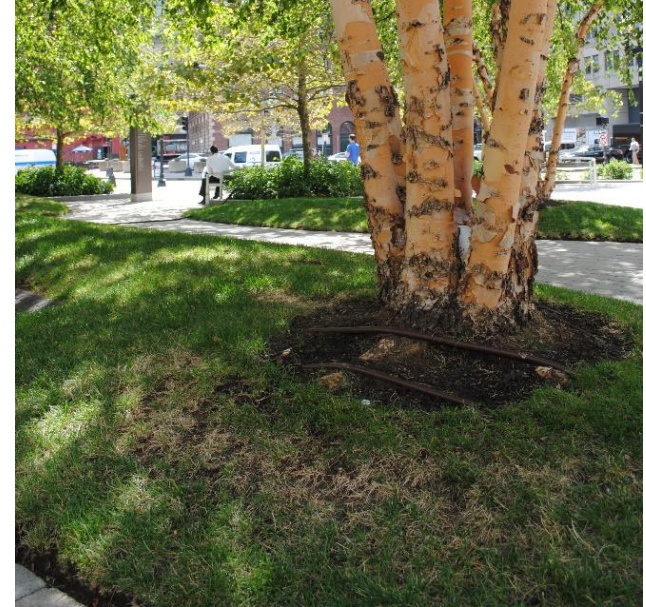
DRIP IRRIGATION SYSTEM RETROFIT

Design/Install Flaw

- The below-ground drip irrigation system is insufficient for watering the amigdaloid beds, which are part of the original site design
- The turf is dying as a result, and the birch trees receive inadequate irrigation during the summer
- This problem presents aesthetic issues and negatively impacts park operations

- Convert the existing drip zone into a spray zone by capping drip lines and installing new pipping with 35 -40 spray heads
- Contract out

- **Cost Estimate:** \$7,000 – 10,000

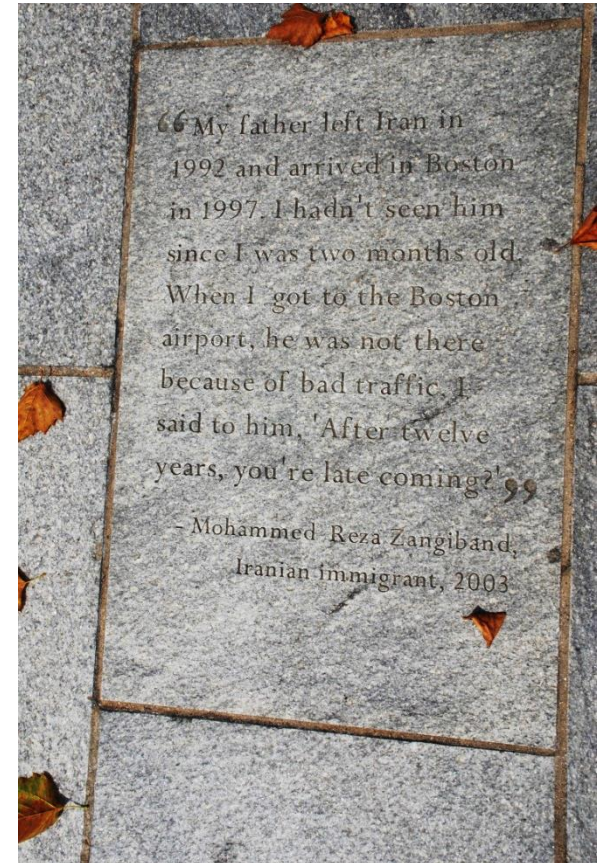
WHARF DISTRICT ENGRAVINGS FADING

Normal Deterioration

- **Details:**
 - Hardscape engravings in the Wharf District, including the Immigrant Letters engravings, are fading
 - This problem presents aesthetic issues
- **Repair Options:**
 - Paint with lithichrome paint
 - In-house repair or contract out
- **Cost Estimate:** \$2,500 – 5,000

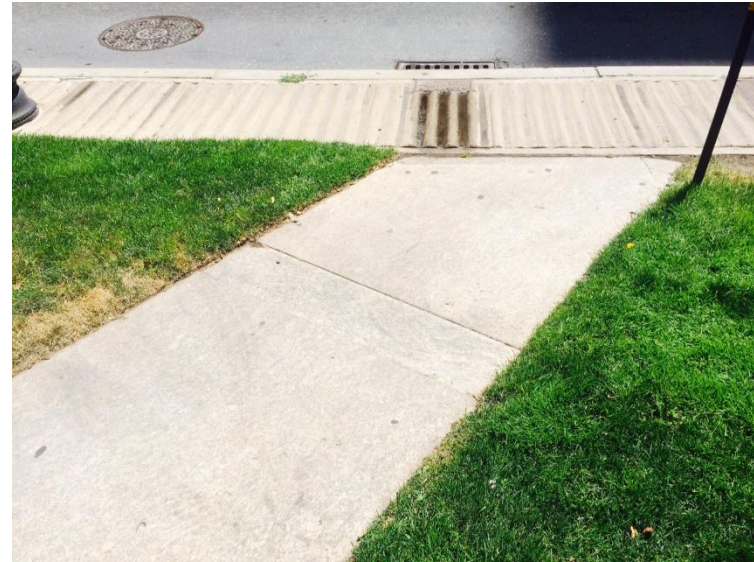
SIDEWALK REMOVAL

Design/Install Flaw

- **Details:**
 - The sidewalk leads to a non-pedestrian paved strip, entering Atlantic Ave with no correlating crosswalk
 - Add light-touch landscape improvements
 - This problem presents an aesthetic issue and is a safety hazard
- **Repair Option:**
 - Jackhammer removal of sidewalk and its base; replace with soil & sod
- **Cost Estimate:** \$10,000 – 15,000

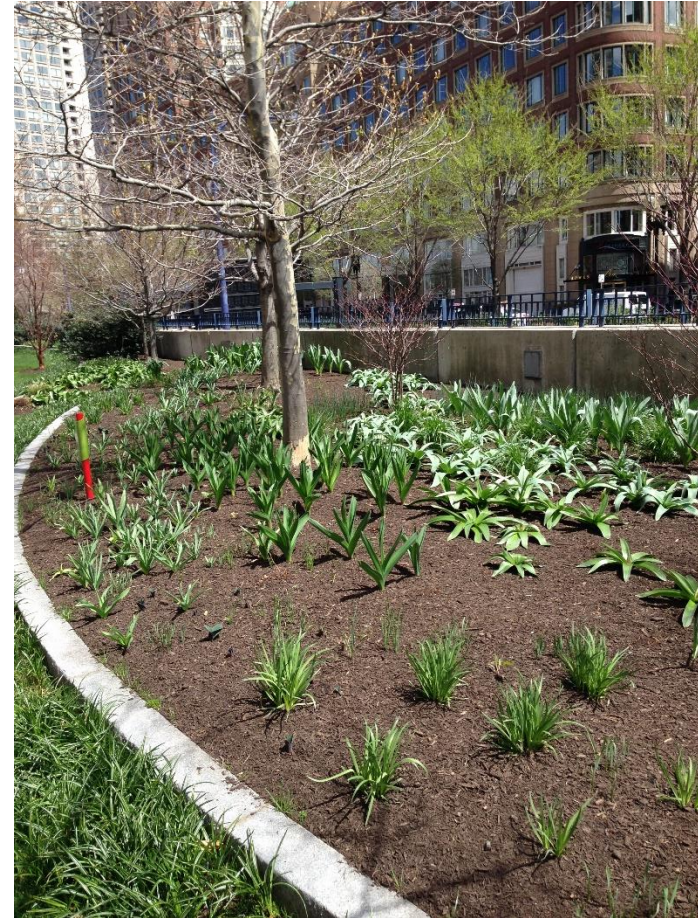
P18 IRRIGATION

Design/Install Flaw

- **Details:**
 - Currently only the lawns are irrigated on P18
- **Repair Option:**
 - Install drip irrigation system into beds
- **Cost Estimate:** \$10,000 – 15,000

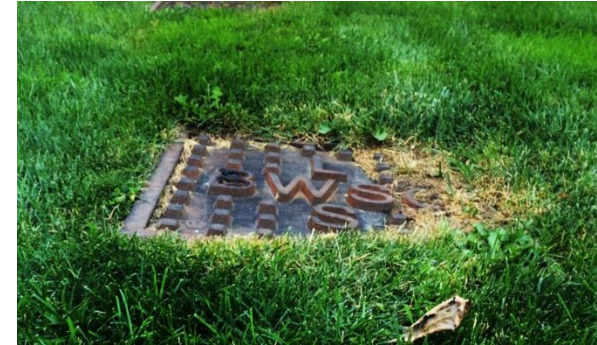
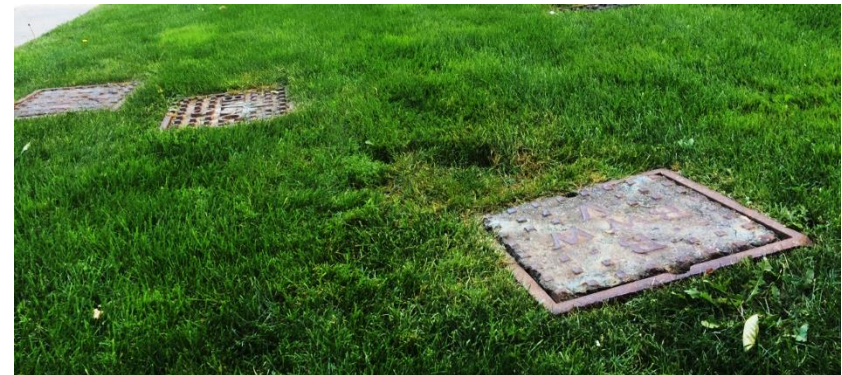
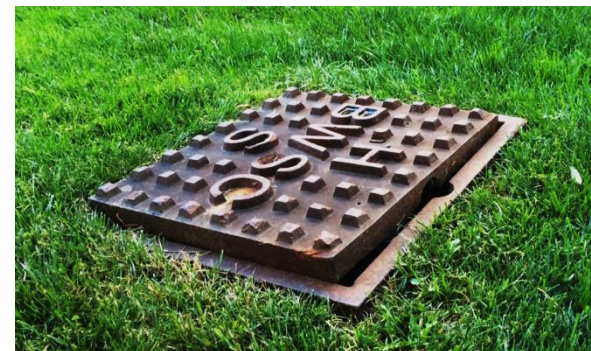
RESET UTILITY COVERS

Design/Install Flaw

- Utility covers do not match the ground elevation, which has only been amplified with settling that occurs naturally over time
- 6 units need to be adjusted
- This problem presents an aesthetic issue, negatively impacts park operations and is a trip hazard

- Reset the frame to the appropriate elevation; some regrading of the soil will be required

- **Cost Estimate:** \$20,000 – 30,000

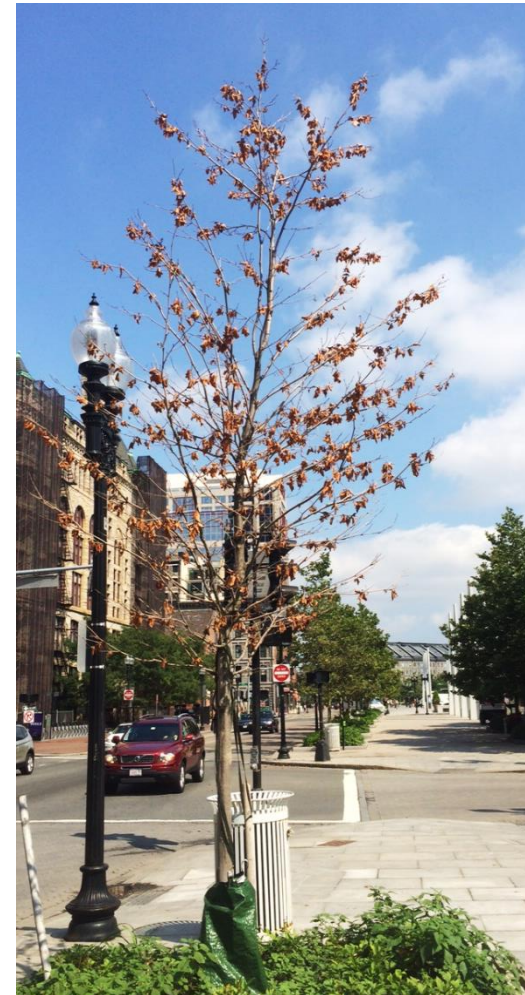
PROMENADE LONDON PLANE TREES

Cause Unknown

- **Details:**
 - Seven trees currently in need of removal
 - Spread throughout the Wharf District parks
 - Plans in place to remove two trees and investigate the tree pit for causes
 - This problem presents aesthetic issue and is a safety hazard
- **Repair Option:**
 - Replace with new trees
- **Cost Estimate:** \$20,000 – 25,000

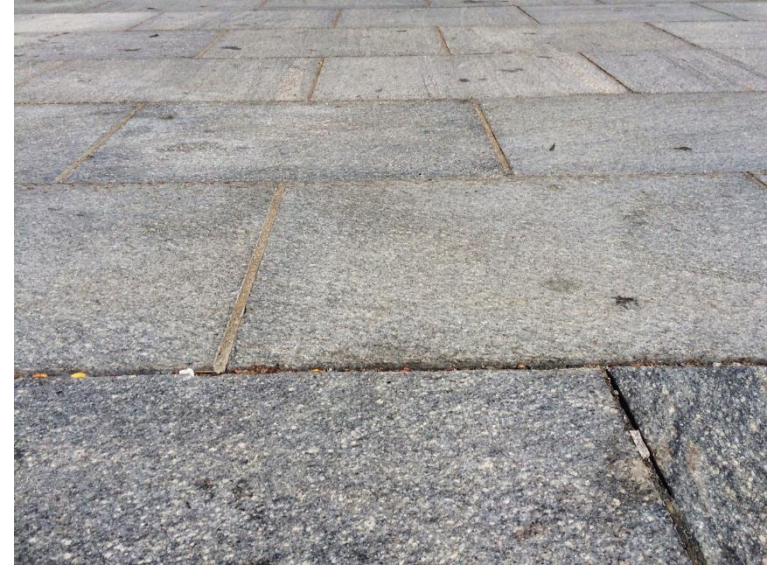
RE-GROUT FOR JOINT ISSUES

Normal Deterioration

- Joints need to be re-pointed or re-caulked due to normal deterioration
- If not done, water enters joint, freezes and causes pavers to heave
- Amount of work is beyond the time capacity of the Greenway team
- This problem presents an aesthetic issue, will continue to deteriorate and increase repair cost, and negatively impacts park operations

- Re-point or re-seal joints where mortar or sealant have failed
- Contract out

- **Cost Estimate:** \$25,000 – 30,000

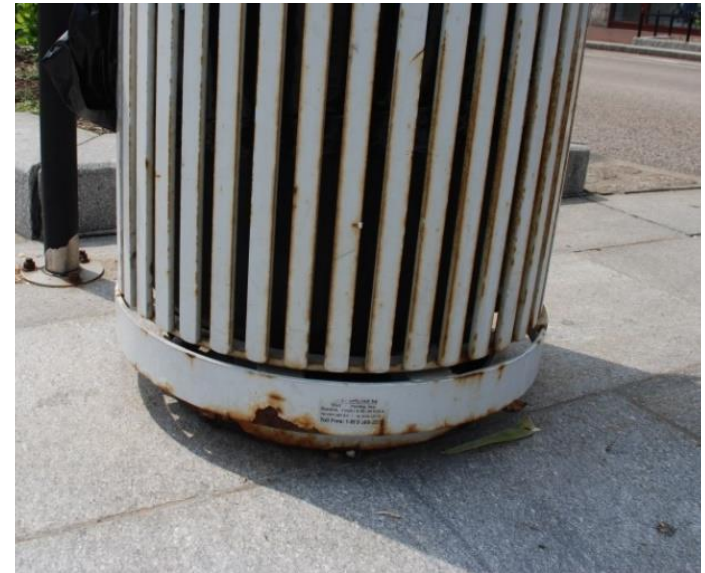
TRASHCANS

Design/Install Flaw & Normal Deterioration

- As a park, there is a movement to transition to a unified barrel system with side by side recycling and consistent branding
- The white industrial metal trash cans throughout the Wharf District Parks are rusting due to non-galvanized manufacture, causing unsightly appearance
- There are 23 barrels in the Wharf District
- This problem presents an aesthetic issue

- Remove current trash cans; replace with new ones

- **Cost Estimate:** \$65,000 – 100,000

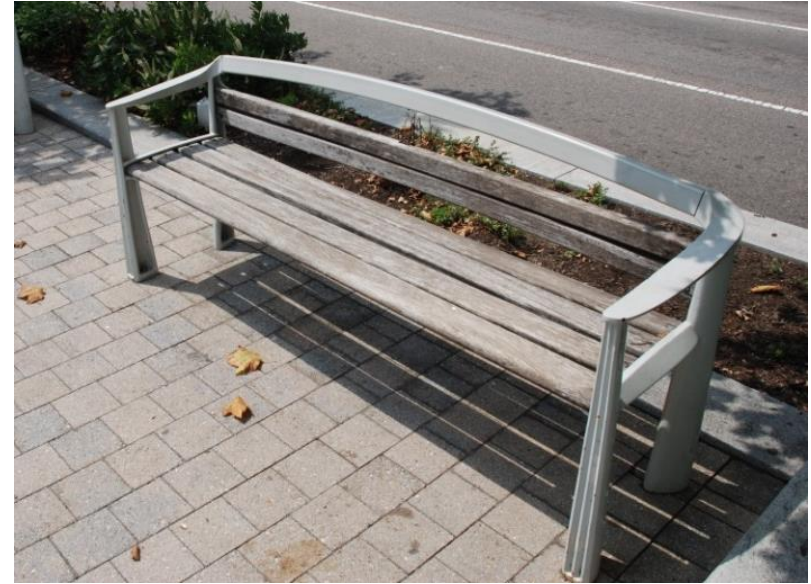
METAL AND WOOD BENCHES

Normal Deterioration

- Wear and tear have damaged the metal finishing; exposed metal has started to rust
- There are a total of 75 benches in the Wharf District Parks
- Some wooden slats on the benches are badly warped – 18 top slats and 28 bottom slats need replacing
- This problem presents aesthetic issues and concerns a basic park amenity

- Investigate whether refinishing the benches would be cost-effective; otherwise, replacements are needed

- **Cost Estimate:** \$30,000 – 50,000

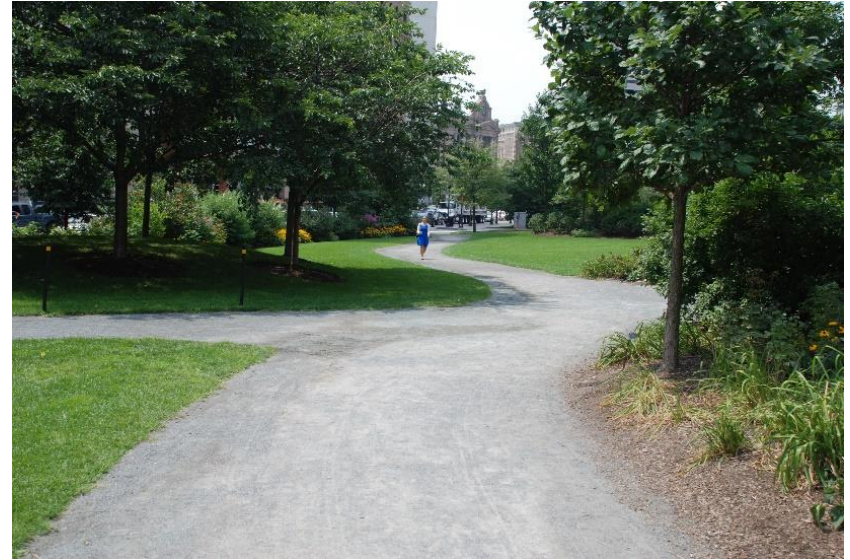
STONE DUST PATH MAINTENANCE PROBLEMS

Design/Install Flaw

- **Details:**
 - Stone dust path cannot stand up to high-intensity use during most of the year, or be plowed during the winter
 - Strong rainstorms cut channels into the path, making it uneven; pedestrians use at their own risk during the winter
 - There is considerable erosion of the path complicating maintenance of the park
 - This problem presents an aesthetic issue, concerns a basic park amenity and negatively impacts park operations

- **Repair Option:**
 - Design and install a more durable asphalt or Chipseal path
- **Cost Estimate:** \$50,000 – 100,000

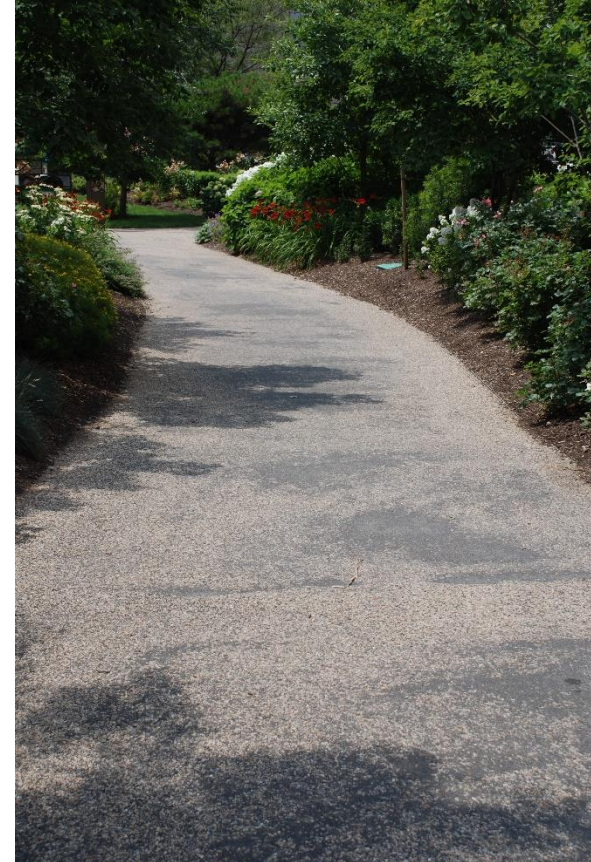
CHIPSEAL PATH DEFECT

Design/Install Flaw

- **Details:**
 - Path has permanent aesthetic flaws due to installation problems
 - Most of the pebbles that were supposed to adhere to the asphalt base layer are gone
 - This problem presents aesthetic issues
- **Repair Options:**
 - Remove and reinstall the path
 - Contract out
- **Cost Estimate:** \$25,000 – 40,000

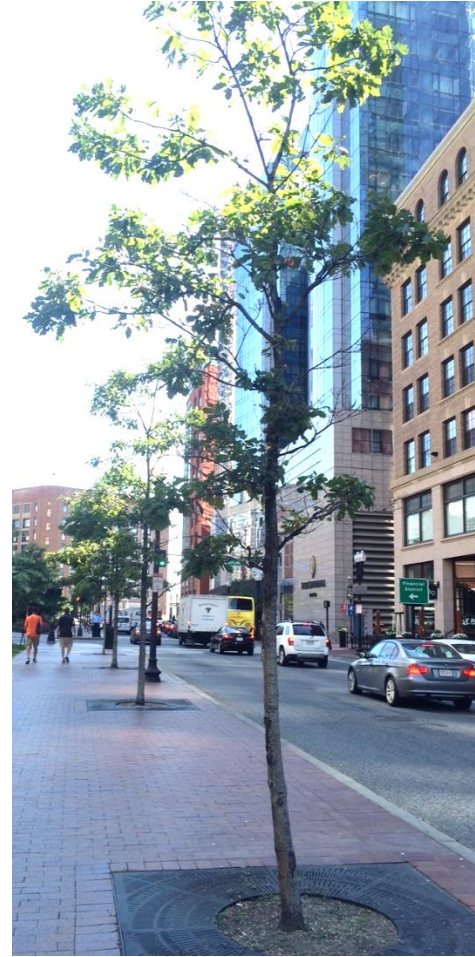
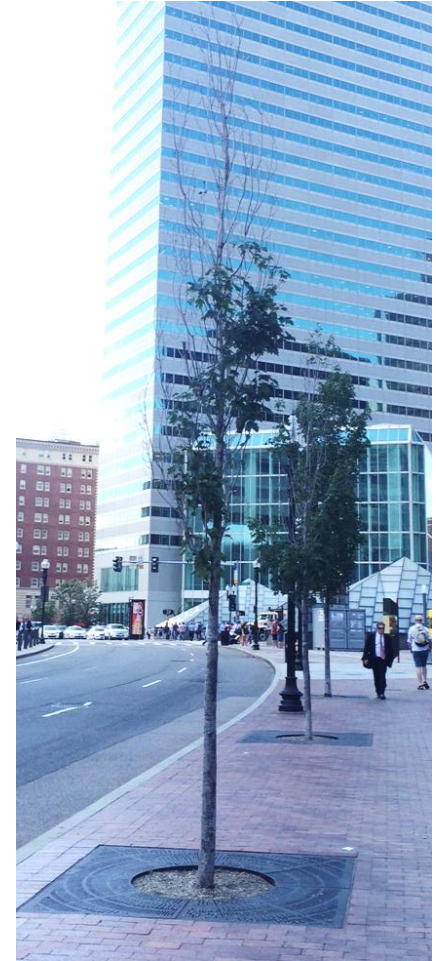
STREET TREES

Cause Unknown

- **Details:**
 - 24 trees along the Atlantic Street side of these three parcels have failed to establish
 - Potential cause could be the underground steam line effecting tree roots
 - This problem presents an aesthetic issue
- **Repair Option:**
 - Remove and replace, either with a 3” caliper tree or with a bigger more mature tree
 - Pending confirmation of cause, consideration for re-design *
- **Cost Estimate:** \$36,000 – 50,000+

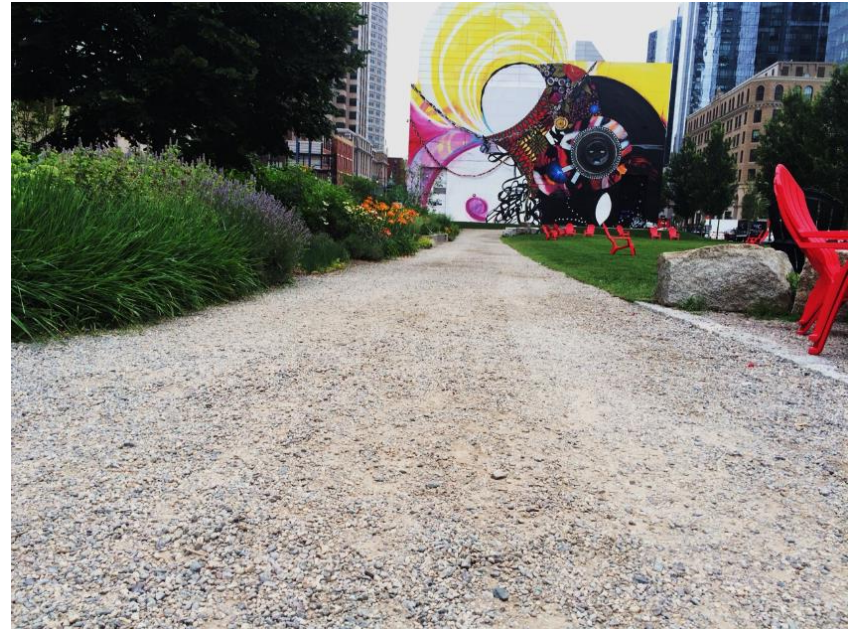
RE-GRADE DEWEY ROAD

Normal Deterioration

- The nature of a gravel road requires regrading as result of use
- The road on Dewey has become uneven, and the number of ruts are increasing
- This problem presents an aesthetic issue, will continue to deteriorate, increasing repair costs, and negatively impacts park operations

- Regrade the road
- Contract out

- **Cost Estimate:** \$2,500 – 5,500

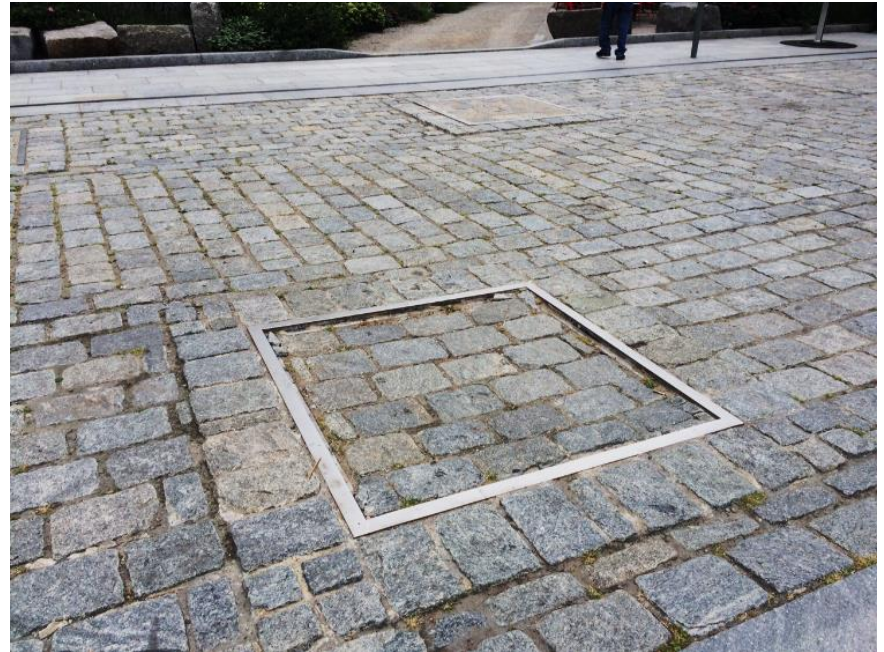
GRANITE PAVERS SETTLING

Normal Deterioration

- **Details:**
 - Natural settling of the pavers, and the dynamic nature of the tunnel, causes an uneven surface
 - This presents an aesthetic issue and is a safety hazard
- **Repair Option:**
 - Contract out
- **Cost Estimate:** \$6,000 – 10,000

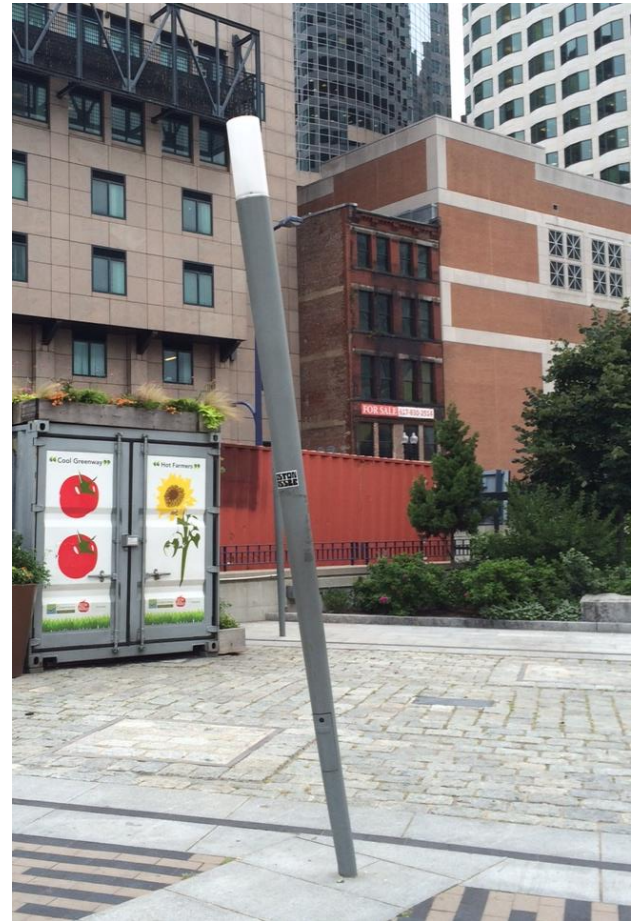
LEANING LIGHT POLE

Accident/Vandalism

- **Details:**
 - Light pole leans to one side; cause due to impact from vehicle
 - This problem presents an aesthetic issue
- **Repair Option:**
 - Remove and replace granite base and existing pole
 - Contract out
- **Cost Estimate:** \$6,500 – 8,000

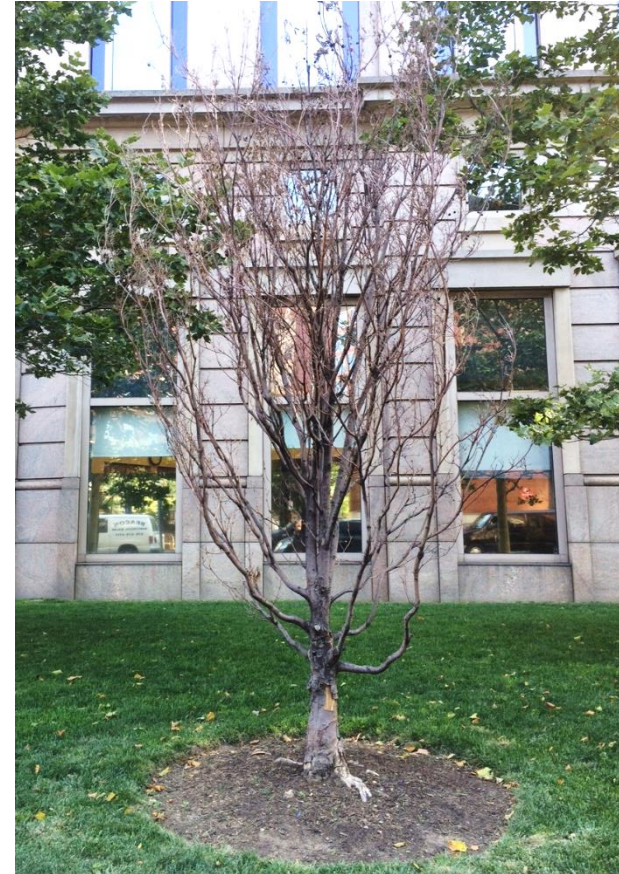
LAWN TREES – DOGWOOD DISEASE

Cause Known

- **Details:**
 - Decline of 8 Dogwood trees from the original design due to disease
 - One tree has been removed; 7 left to address
 - This problem presents an aesthetic issue and will continue to deteriorate, increasing repair costs.
- **Repair Option:**
 - Remove and replace, potentially with an improved species
- **Cost Estimate:** \$5,000 – 15,000

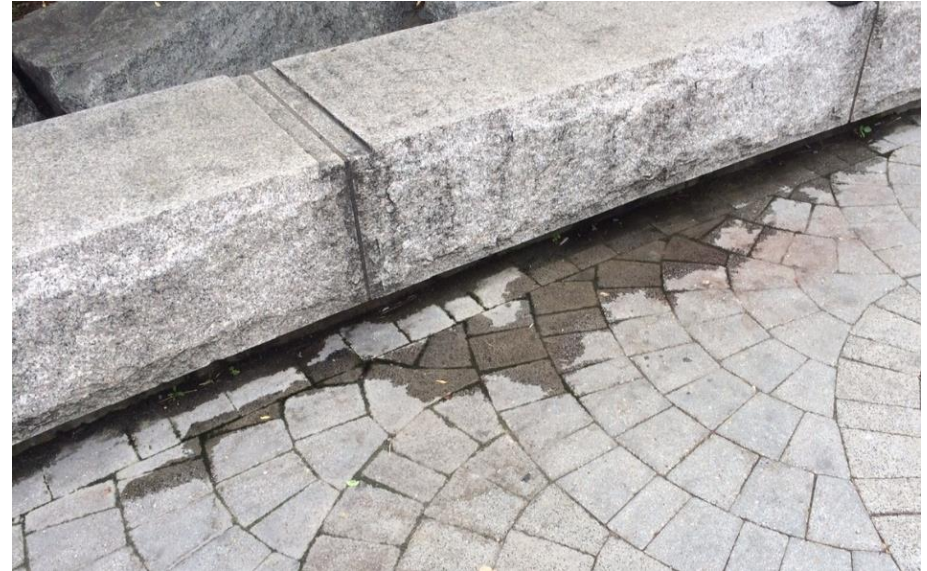
FOUNTAIN FIXTURE LEAK

Normal Deterioration

- **Details:**
 - Flexible sealant used is waterproofed, but has a limited life span
 - Worsens with time, as the sealant's waterproof abilities fade
 - This problem presents an aesthetic issue
- **Repair Option:**
 - Re-seal with flexible sealant
 - In-house
- **Cost Estimate:** \$3,500 – 4,000

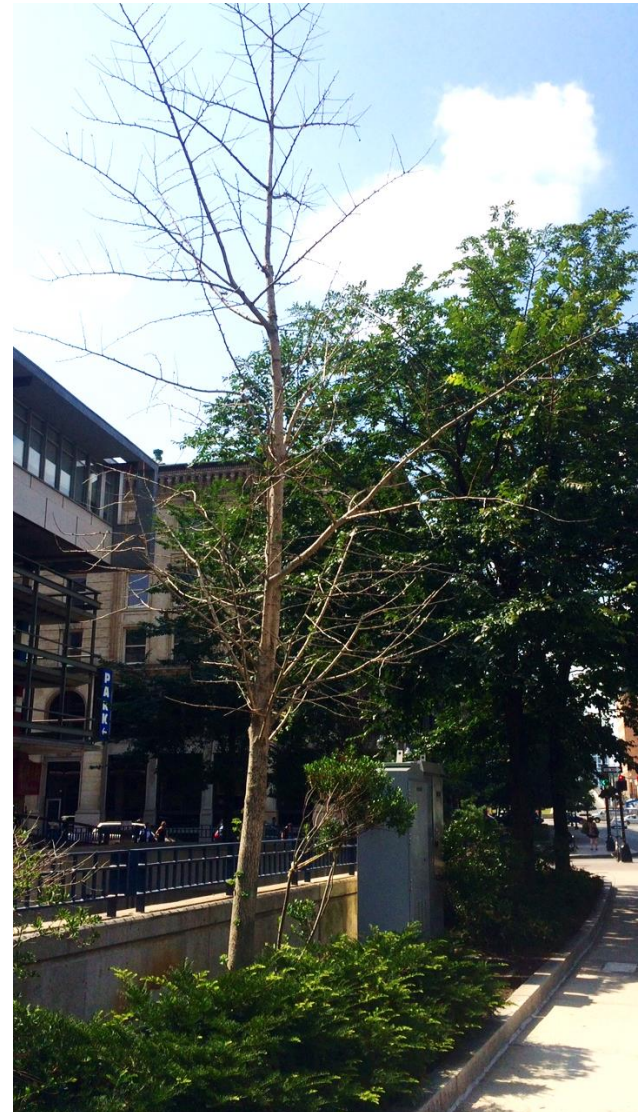
GINKGO TREES

Cause Known

- **Details:**
 - Two trees currently in need of removal
 - Result of winter stress and impact of interrupted irrigation
 - This problem presents an aesthetic issue and is a safety hazard
- **Repair Option:**
 - Replace with new trees
- **Cost Estimate:** \$5,000 – 7,500

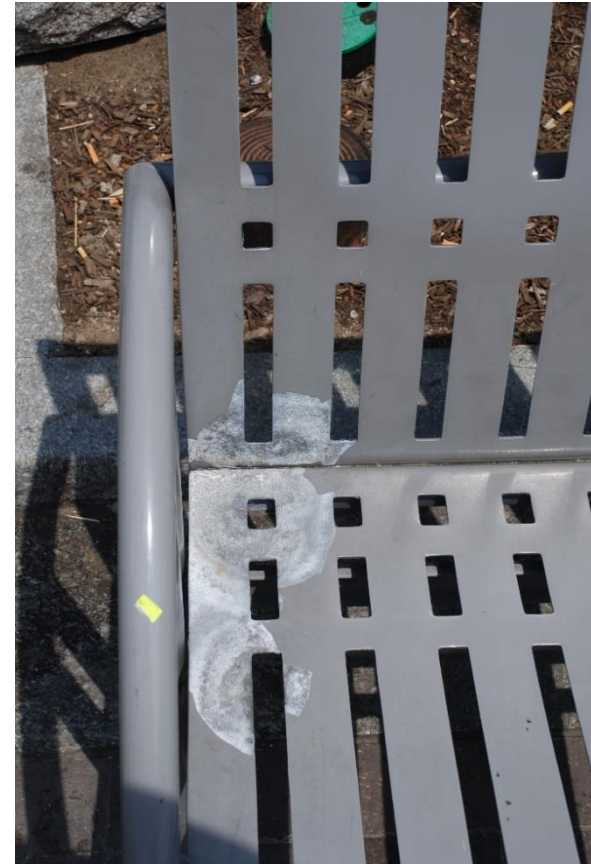
METAL BENCH FINISH DAMAGE

Normal Deterioration

- **Details:**
 - Paint is chipping off all 4 benches due to normal use
 - While chipping is not as severe or noticeable on all the benches, at least one bench is in very poor condition and needs to be removed and re-finished off-site
 - This problem presents an aesthetic issue
- **Repair Options :**
 - Sand, seal, and paint benches with a powder finish off-site
 - Contract out
- **Cost Estimate:** \$10,000 – 15,000

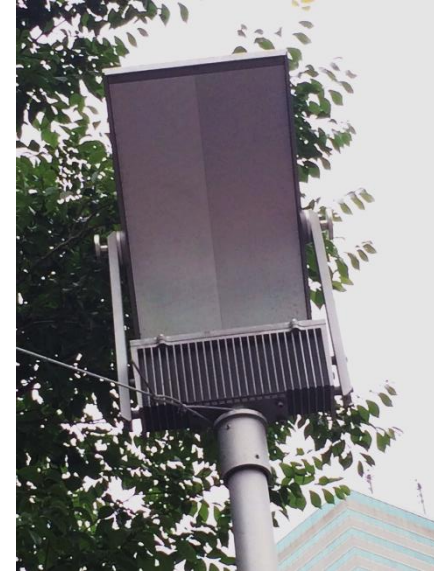
LED LIGHT UPGRADE

Design/Install Flaw

- **Details:**
 - Current light fixtures do not provide adequate light levels and are costly to maintain
 - Transitioning to LED light fixtures will reduce maintenance costs, reduce energy use and provide increased level of illumination
 - There are a total of 23 lights. One light has been replaced as a test case and was successful
 - This problem presents an aesthetic issue and is a safety concern

- **Repair Option:**
 - Remove current light fixtures, replace with the LED light packages
- **Cost Estimate:** \$15,000 – 18,000
