RoseKennedyGreenway.org

CAPITAL REPAIRS REPORT

Summer 2015

CAPITAL REPAIRS INVENTORY

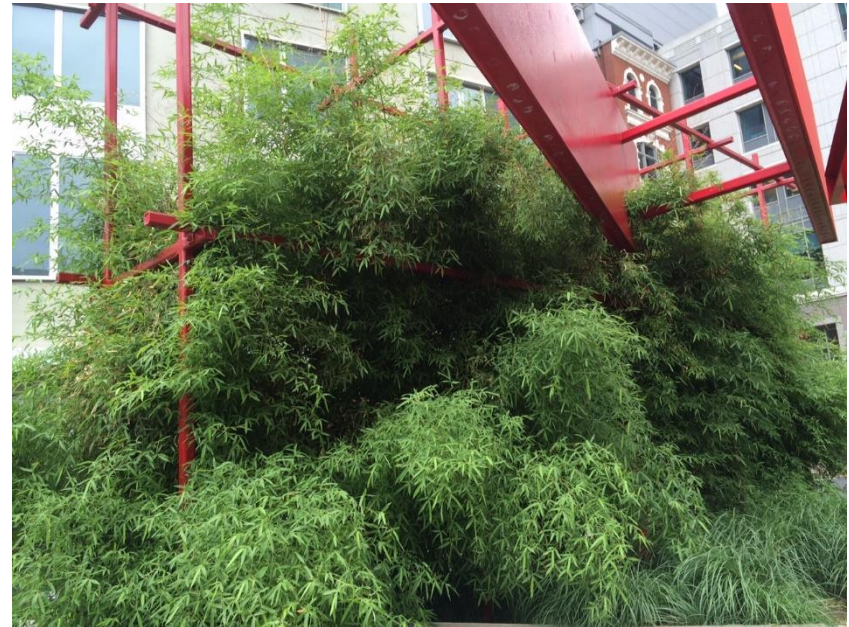
ADDITIONAL RAILING ON RED CAGES

Design/Install Flaw

- **Details:**
 - When the bamboo is young, there are no horizontal rails to support its growth, and it spills out
 - Additional horizontal rails would contain the bamboo
 - This problem presents an aesthetic issue and negatively impacts park operations
- **Repair Option:**
 - Install additional supports
- **Cost Estimate:** \$20,000 – 30,000
