# Capital Repairs Inventory

- A capital repair is defined as a repair needed which exceeds \$5,000
- This inventory of items in need of repair on the Rose Kennedy Greenway was updated in Fall 2016.
- This report is not intended to capture anticipated future capital repair needs nor reflect the funding that would be necessary annually or over time.
- The ranged cost estimates for each item are very preliminary. Wide ranges are used in cases of significant uncertainty.
- The Rose Kennedy Greenway Conservancy does not currently have a capital reserve or sufficient funding necessary to address the vast majority of these items.
- This report does not include the following:
  - City Street Trees Will be upgraded by MassDOT as part of State City transfer
  - Parcels 2 Not included in our lease temporarily
  - 6 and 12 Undergoing MassDOT BPDA community process

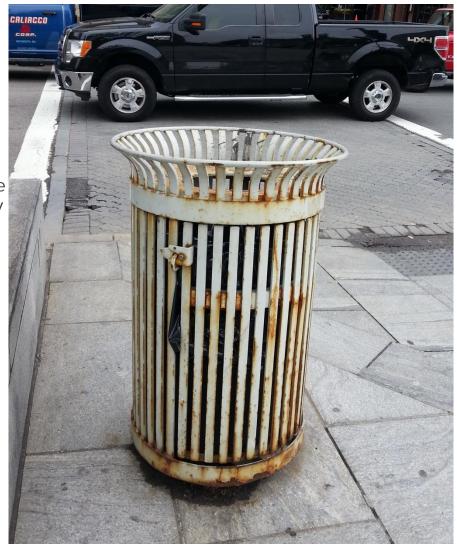
# Replace Rusted Trash Barrels

- Close to 30% of the barrels throughout the Greenway are in poor condition
- Only 29% of Greenway barrels include a recycling option
- Some of the worst barrels (Wharf District Park)
  are ungalvinized steel, which is an inappropriate
  material for outdoor use, and are rusting heavily
- This presents an aesthetic issue
- Priority Level: High

- Replace some or all with new barrels, include a recycling option at every location
- Sub out removal and installation

- Replace ALL barrels \$115,000 \$150,000
- Replace worst (Wharf) barrels \$25,000 -\$55,000

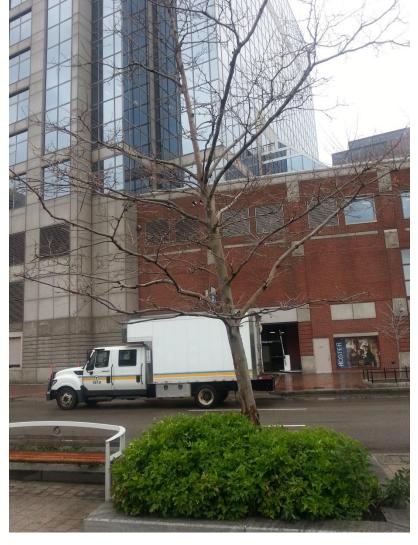
# Replace Unhealthy Greenway Trees

- Periodically, trees throughout the Greenway fail for various reasons, including insect damage, irrigation failures, environmental stress, and vandalism/accidental damage.
- This presents an aesthetic and a safety issue
- Priority Level: High

Replace trees with 3"-4" caliper replacements (standard replacement size due to ease of installation, cost, and ability to properly establish)

\$28,000 – 11 PARK tree replacements

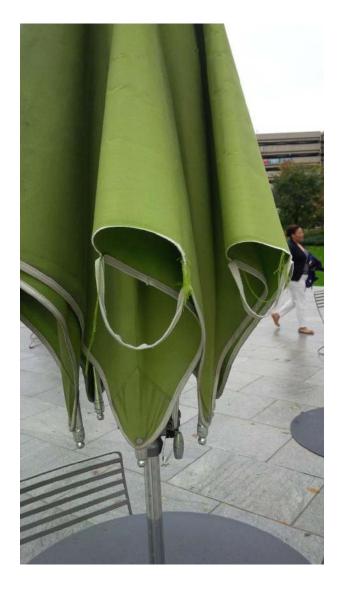
# Replace/Repair Damaged Umbrellas

- 9 umbrellas need to be replaced. There are currently 41 umbrellas across the Greenway, this is down from 48 in 2015.
- The umbrella canopies will begin to need replacing on a yearly basis as they reach the end of their lifespan (4-6 yrs)
- Some complete umbrellas will need replacing on a yearly basis due to general wear and tear
- This presents an aesthetic issue
- Priority Level: High

Inspect and replace canopies and umbrellas on a yearly basis

\$13,000 to replace 9 umbrellas and ¼ of the canopies for 2017

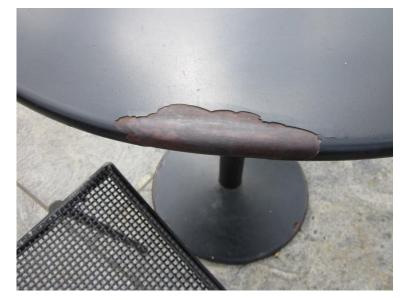
# Replace Worn-out Tables & Chairs

- 24 tables on P10, P15 & 16, and P22 are deteriorating. They now need to be refinished and repaired annually which is a strain on park ops. Even with these repairs, they remain unsteady and unsightly
- 28 old wire mesh chairs on P10 are also deteriorating
- This presents an aesthetic issue and negatively impacts park operations
- Priority Level: Low

- Replace tables and chairs with higher quality "standard" Greenway furniture
- **Cost Estimate:** \$32,000
  - Chairs \$7,000
  - Tables \$25,000

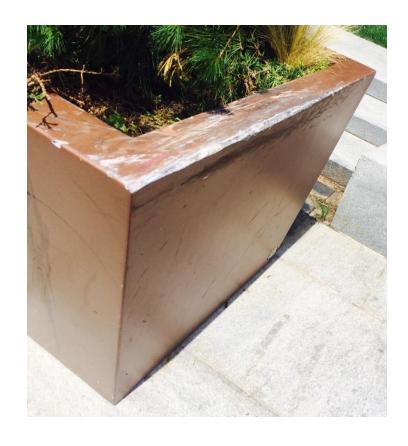
# Repair Damaged Containers

- Damage primarily incurred as a result of vandalism/accidents
- Approximately a dozen containers of various size and style need to be repaired
- This presents an aesthetic issue
- Priority Level: Medium

- Replacements for severe damage;
  Contract out repair work
- **Cost Estimate:** \$6,000 12,000

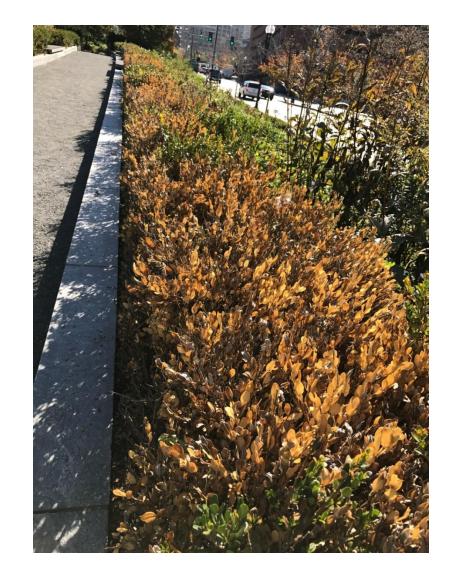
# Renovate P10 Boxwood Beds

- The Boxwood Beds on P10 are overrun with invasive Vetch, the Boxwoods are dying due to improper installation (overcrowding), and there is lack of diversified plant material here, resulting in only one season of horticultural interest
- Renovations would be in line with the new boxwood design on Parcel 8, which was installed the summer of 2015
- This problem is an aesthetic issue, negatively impacts park operations, and is getting worse
- Priority level: High

- Amend existing design in house, Contract out renovations
- **Cost Estimate:** \$275,000 \$350,000

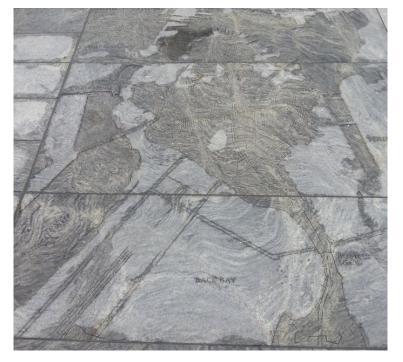
# Repair North End Engravings

- Details of historical map on southwest corner are wearing and chipping
- Engraving near the northeast corner of the park is fading
- This presents an aesthetic issue
- Priority Level: Low

- Repair damaged map features and paint with lithichrome paint
- Contract out
- **Cost Estimate:** \$5,000 \$9,000

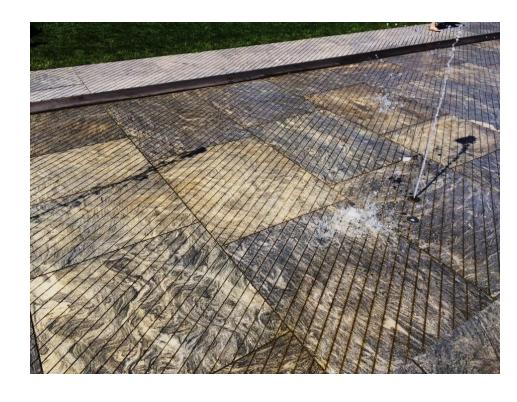
# Reset Fountain Slabs

- 7 slabs in the fountains need to be reset due to frost heaving
- This presents an aesthetic and a safety issue
- Priority Level: Medium
- Repair Option:
  - Contract out work
- Cost Estimate: \$12,000 \$14,000

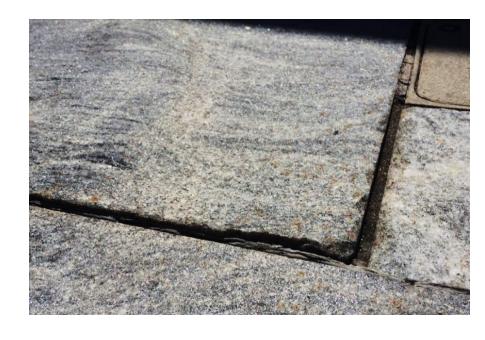
# Reset Granite Pavers

- 14 slabs need to be reset due to frost heaving
- Pavers need to be recaulked.
- This presents an aesthetic and a safety issue
- Priority Level: Medium

- Contract out
- **Cost Estimate:** \$25,000 30,000

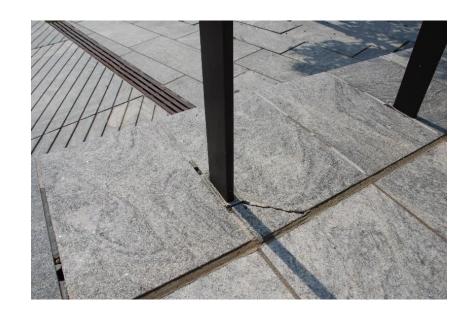
# Reset/Replace Granite Caps & Pavers

- The bases of the fountain railings were not installed properly allowing moisture to seep through the spaces between the stones. Freezing conditions put stress on the joints, causing 6 stone caps and adjacent granite pavers to crack
- This presents an aesthetic issue; as it continues to deteriorate, repair costs may rise
- Priority Level: Low

- All of the 6 caps need to be reset, some replaced (labor only), but those on the north side of Parcel 10 and south side of Parcel 8 are priorities
- In-house repair or contract out
- Cost Estimate: \$20,000 30,000

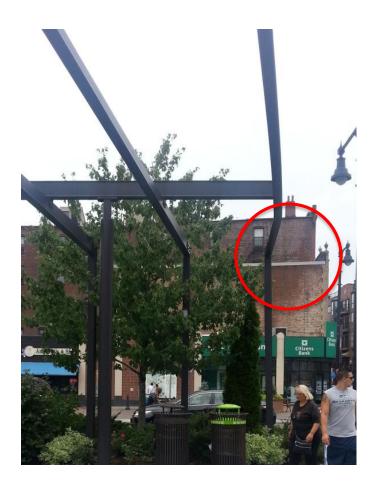
# Repair Bent Pergola

- The southern purlin on P8 is bent due to damage from a car accident
- The expectation is that the drivers insurance will cover this repair
- This presents an aesthetic and a structural issue
- Priority Level: High

Contractor to repair damaged purlin

Insurance adjuster is currently investigating cost and coverage

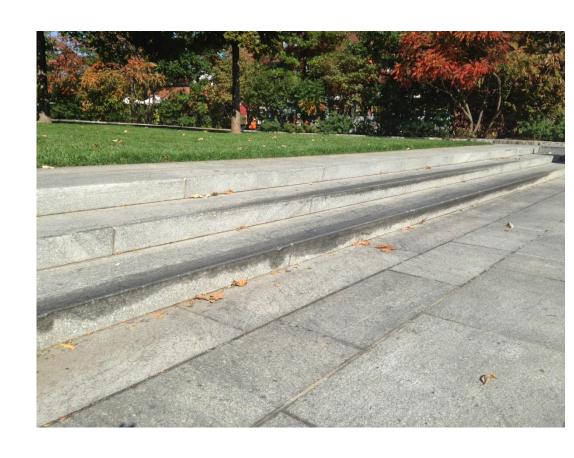
# Prevent Further Skateboard Damage

- Skateboarders are damaging park features
- This presents an aesthetic issue; as it continues to deteriorate, repair costs may rise
- Priority Level: Medium

- Add new skate deterrents
- Contract out

- \$50,000 - 70,000

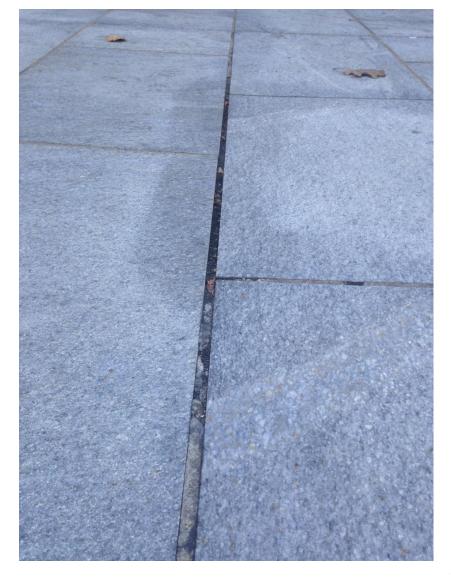
# Repair Park Masonry

- Remove and reset 600sf of granite pavers (High priority)
- Remove and reset concrete pavers at promenade (Medium priority)
- Remove and reset pavers around light pull boxes (Low priority)
- Stone veneer and curb repairs (Low priority)
- Repoint and reseal joints in granite pavement

- Contract out
- **Cost Estimate:** \$60,000 \$100,000

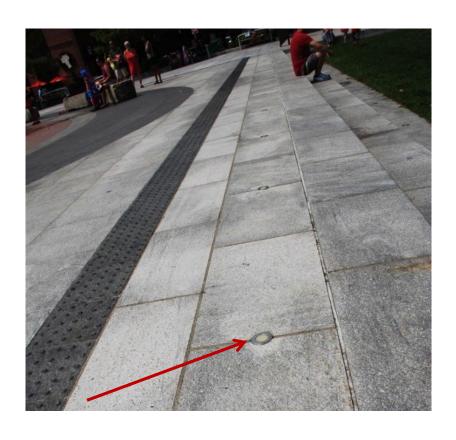
# Replace Rings Fountain Step Lights

- All of the 29 lights embedded in the steps adjacent to the Rings Fountain do not function
- This presents an aesthetic issue
- Priority Level: Low

- Install new light fixtures
- **Cost Estimate:** \$12,000 15,000

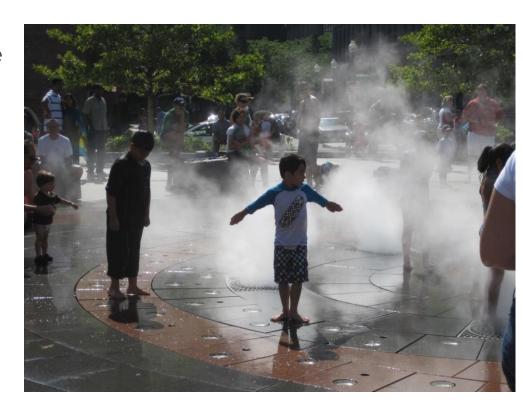
# Repair Rings Fountain Fog

- There is a leak in the high pressure stainless steel pipe that supplies water to the fog manifolds. These pipes are imbedded in the concrete fountain basin making it costly to repair.
- Priority Level: Medium

- Requires further investigation
- Contract out
- **Cost Estimate:** \$50,000 \$100,000

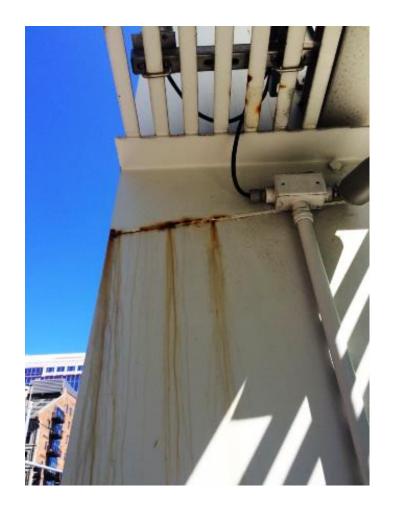
# Refinish Lightblades, Pole Lights, Utility Boxes

- 19 pencil light fixtures , 12 light blades, 6 bike racks, and 8 electrical cabinets throughout Wharf District need to be refinished
- This presents an aesthetic issue
- Priority Level: Medium

On-site work, Contract out

• Cost Estimate: \$10,000 - 14,000

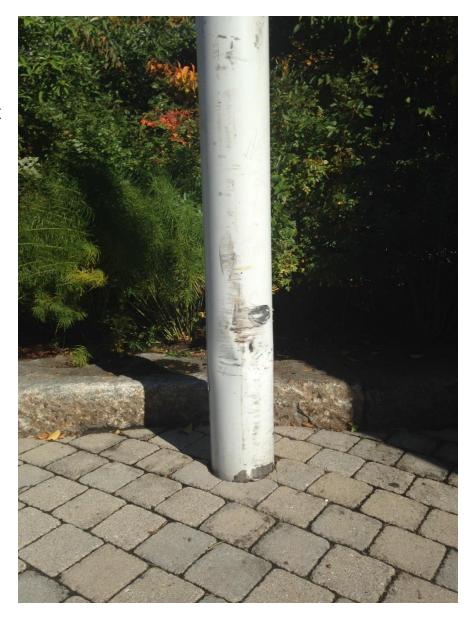
# Replace P17 lightpole

- This lightpole has been hit by a food truck that parks adjacent to it
- The expectation is that the trucks insurance will cover this repair
- Priority Level: Medium

- Contractor to install new lightpole
- **Cost Estimate:** \$7,500 \$12,500

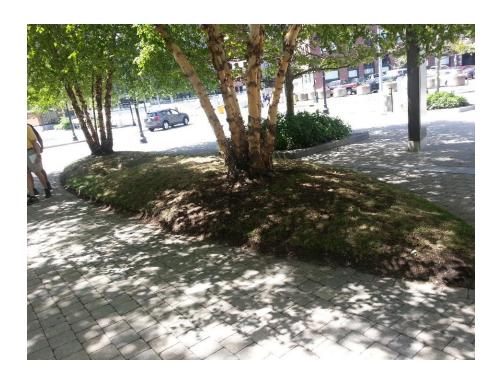
# Convert River Birch Beds Irrigation

- The drip irrigation system is insufficient for watering the river birch beds
- The turf is dying as a result, and the birch trees receive inadequate irrigation during the summer
- This presents an aesthetic issue and negatively impacts park operations
- Priority Level: Low

- Convert the existing drip zone into a spray zone by capping drip lines and installing new pipping with 35 -40 spray heads
- Contract out
- **Cost Estimate:** \$7,000 \$10,000

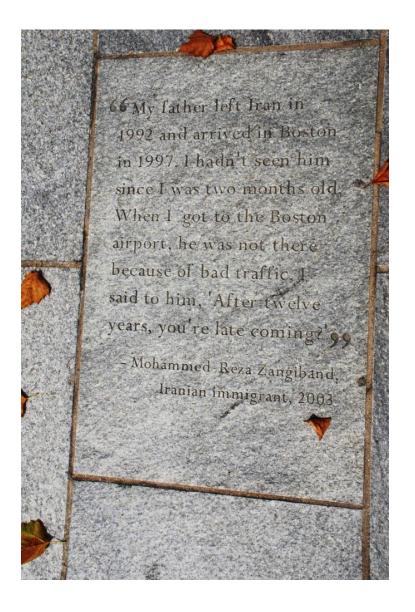
# Touch-up Engravings

- Hardscape engravings in the Wharf District, including the Immigrant Letters engravings, are fading
- This presents an aesthetic issue
- Priority Level: Low

- Paint with lithichrome paint
- contract out
- Cost Estimate: \$9,000

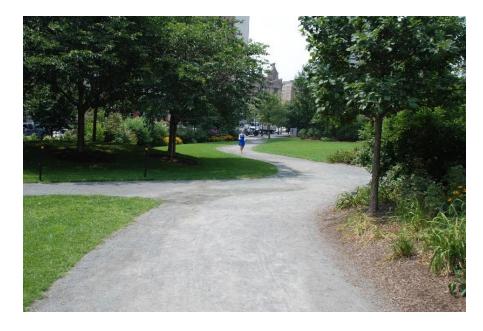
# Rebuild P19 Pathways

- Stone dust paths do not stand up well to highintensity use or plowing
- There is considerable erosion on the paths, which can cause uneven walking surfaces. This requires frequent maintenance to address.
- Lighting on these paths is insufficient.
- This presents an aesthetic and a safety issue and negatively impacts park operations
- Priority Level: Low

- Install a more durable material, such as asphalt, chipseal, concrete or recycled rubber
- Light pathways with either pole lights or bollard lights

#### Cost Estimate: \$275,000 – \$425,000

- Pathway resurfacing \$125,000 \$175,000
- Pathway lighting \$150,000 \$250,000

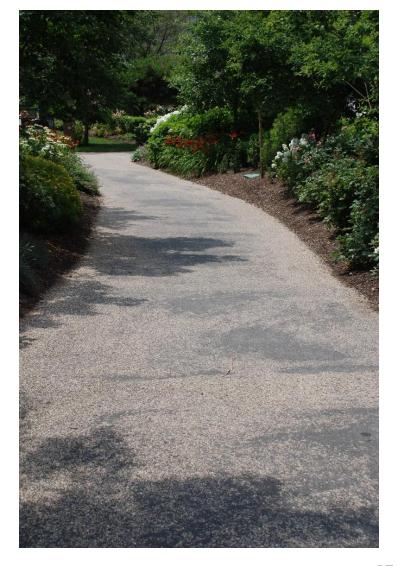
# Restore Chipseal Path

- Path was installed incorrectly, creating aesthetic flaws
- Most of the pebbles that were supposed to adhere to the asphalt base layer are gone
- This presents an aesthetic issue
- Priority Level: Low

- Reinstall the path with chipseal or other surface
- Contract out
- Cost Estimate: \$25,000 40,000

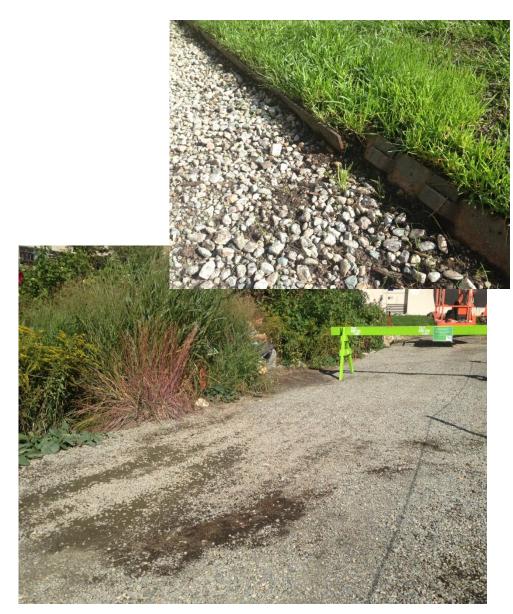
# Regrade Gravel Access Road

- The road on Dewey has become uneven, and the number of ruts are increasing
- The steel edging on the lawn side of the road is bent and protruding at seams, creating a safety hazard
- The gravel road requires periodic regrading as result of frequent use
- This presents an aesthetic and a safety issue, and it negatively impacts park operations
- Priority Level: High

- Regrade the road, replace lawn side steel edging
- Contract out
- **Cost Estimate:** \$7,500 \$8,500

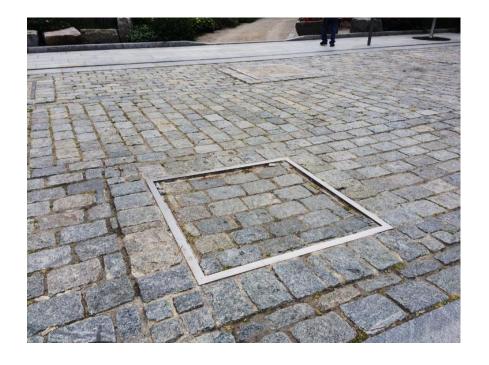
# Reset Cobbles

- Natural settling of the cobbles is causing an uneven surface
- This is a safety and an aesthetic issue
- Priority Level: Low

- Reset the cobbles that have settled the most
- Contract out
- **Cost Estimate:** \$6,000 \$15,000

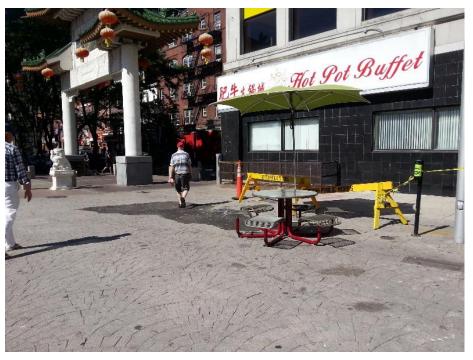
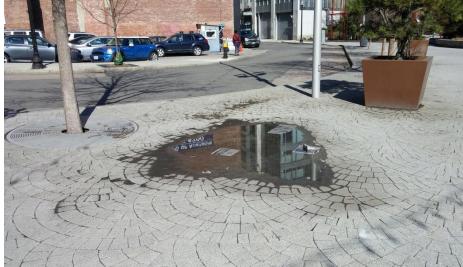
# Repair Plaza At Water Line Repair Site

- Two areas in the plaza need to be repaired – one is an asphalt patch where BWSC repaired a water line; the other a depression in the plaza – cause unknown.
- This is an aesthetic issue
- Priority Level: Medium

- Contract out
- **Cost Estimate:** \$54,000

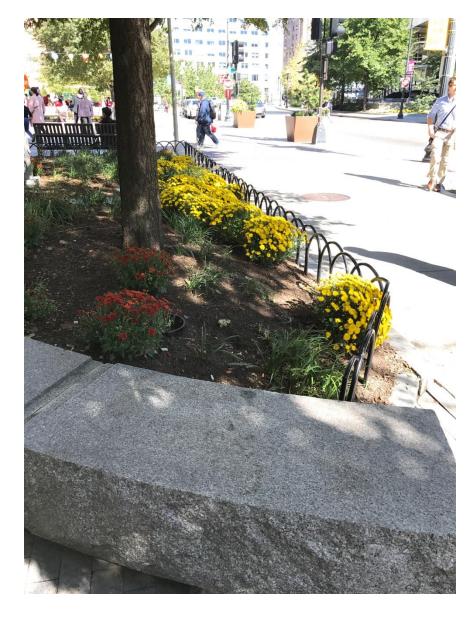
## Renovate Beach St Beds

- The understory plantings at the 2
   triangular beds that flank the Beach
   Street entrance to Chinatown Park have
   dyed out almost completely due to
   competition from the elm trees, lack of
   proper irrigation, and human feet in the
   beds.
- This is an aesthetic issue
- Priority Level: High

- Repair irrigation and plant a resilient understory landscape
- Cost estimate: \$15,000 \$20,000

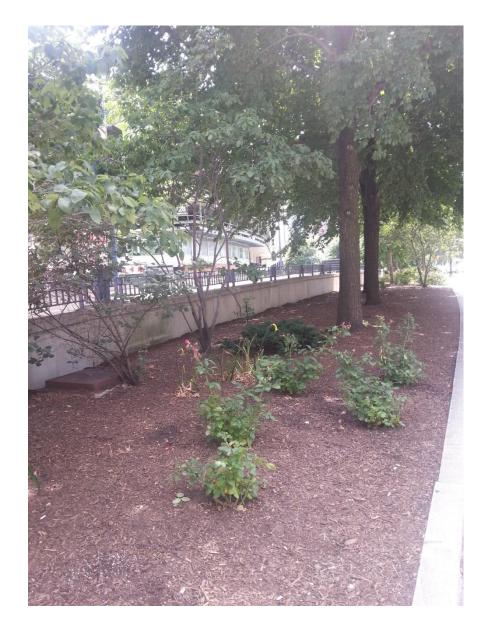
## Renovate East Bed

- The bed to the east of Chinatown park is lacking robust plant material and is not up to Greenway horticultural standards
- Much of the original plant material has died due to a combination of being trampled by homeless camps and lack of proper irrigation
- This is an aesthetic issue
- Priority Level: Medium

- Repair irrigation and replant the bed with site appropriate plantings
- Contract out
- **Cost Estimate:** \$25,000 \$35,000

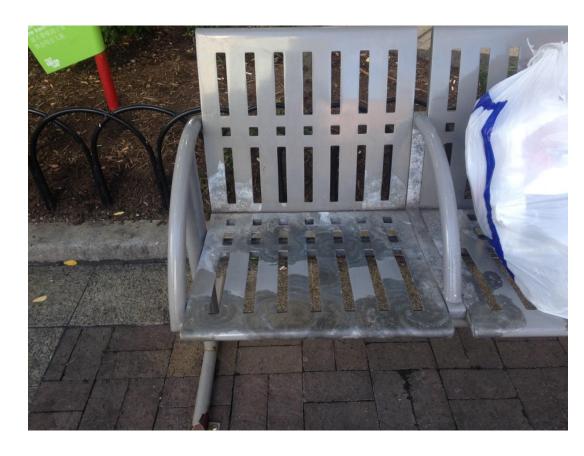
# Replace Park Benches

- Benches are in bad condition and are beyond cost-effective repair
- This is an aesthetic issue
- Priority Level: Medium

- Replace benches
- Cost Estimate: \$8,500

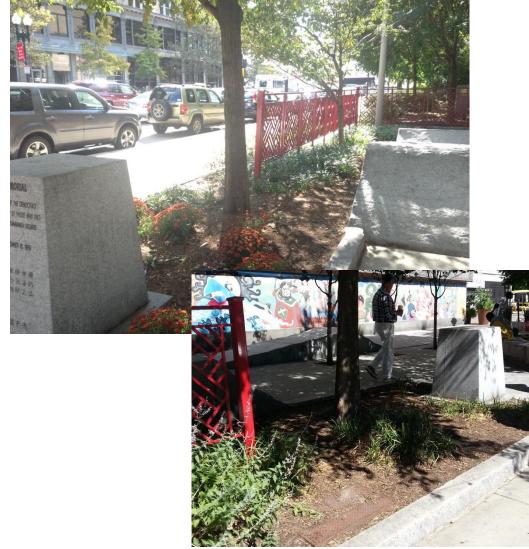
# Relocate and Extend Red Fence

- The red fence along the eastern edge of Mary Soo Hoo Park ends prematurely causing a cut-through through the planting bed.
- The plants on the interior side of this fence are trampled due to people sitting on the concrete mound facing the street with their feet in the bed
- This is an aesthetic issue
- Priority Level: Medium

Set the fence back to the interior edge of the plant bed and extend it an additional 9' to block the cutthrough.

- \$10,000 - \$15,000
