# Rose Kennedy Greenway State of Good Repair

## Summary of Findings

SEPTEMBER 2020

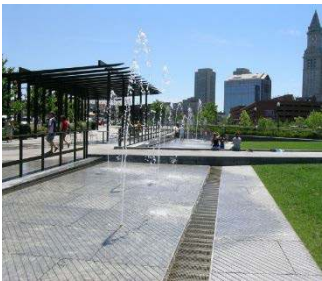
## North Canal Fountain

- The sump pumps have surpassed their lifespan and should be monitored for replacement. Greenway personnel noted that they already monitor the sump pumps frequently for replacement as part of their regular maintenance efforts.
- The exhaust fan has surpassed its lifespan and should be monitored for replacement.
- The vault heater has surpassed its lifespan and should be monitored for replacement.
- Some of the ground sprays are not flush with the fountain decking and are missing escutcheon plates. These conditions can create a tripping and stubbing hazard to patrons - and therefore should be addressed immediately.
- There is a leak in the fountain trough that the Greenway Personnel had identified and have plans to caulk this year.

- The metal grating over the fountain trough needs to be repaired and/or replaced. Some pieces of the grating are exposed creating a hazard to users. Additionally, there are pieces that concave in, creating an uneven surface. Greenway Personnel noted that any hazards in grating are repaired as needed. The grating was designed with inadequate support. Ultimately, either the grates need to be replaced with stronger ones or stainless steel supports need to be welded to the trough.

- It is recommended that the sand for the filter be replaced every eight years instead of every three years.
- The wind sensor at the fountain serves both the North Canal Fountain and the South Canal Fountain. The wind sensor currently does not work. Further investigation is needed to determine what needs to be done to repair the sensor.

- Recommend installing additional water sensors to provide telemetry readout in the event of a failure to prevent vault flooding.

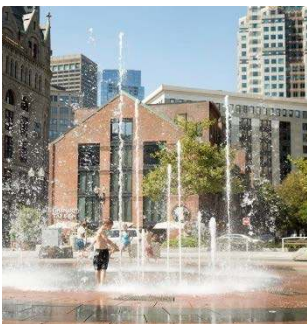
### South Canal Fountain

- The feature pump motor felt hot during operation and should be monitored for replacement over the next couple years.
- Greenway Personnel noted that sump pump #2 was having some issues that they were able to resolve. The sump pumps have surpassed their lifespan and may need to be replaced within the next year. Greenway personnel noted that they already monitor the sump pumps frequently for replacement as part of their regular maintenance efforts

- The exhaust fan has surpassed its lifespan and should be monitored for replacement.
- The vault heater has surpassed its lifespan and should be monitored for replacement.

- Some of the ground sprays are not flush with the fountain decking and are missing escutcheon plates. These conditions can create a tripping and stubbing hazard to patrons and therefore should be addressed immediately.

- The metal grating over the fountain trough needs to be repaired. Some pieces of the grating are exposed creating a hazard to users. Additionally, there are pieces that concave in, creating an uneven surface.

- Interior of the vault is showing signs of heavy corrosion on the conduit, hangers, and supports as a result of the 2009 flooding. These items are not housing or holding recirculation piping. Recommend providing a phased approach to replace rusted hangers and then conduit over the next 3-10 years.

- No wind sensor was identified for the fountain. It is recommended that one is installed since the fountain is located in an area with heavy foot traffic.

- Recommend installing additional water sensors to provide telemetry readout in the event of a failure to prevent vault flooding.

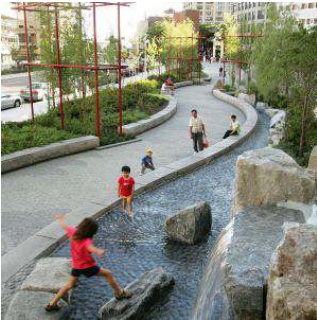
- The fog pump sounded like it had a loose belt. Although this noise has been standard throughout its use the pump should still be monitored and most likely will need replacement in the next 5 to 7 years.

- The solenoid valves are in good working condition but should be monitored for replacement in the next 1 to 5 years.
- The sump pump is replaced every year. A more reliable sump pump should be considered to reduce yearly maintenance efforts.

- It was noted by Greenway Personnel that the cartridges for the micron filter are replaced 1-2 times a year. The cartridges on the micron filter should only need to be replaced every 5 years. It is recommended that the existing micron filter is replaced with a larger one so to reduce to frequency of replacing the cartridges.
