# Rose Kennedy Greenway State of Good Repair

## Summary of Findings

SEPTEMBER 2020

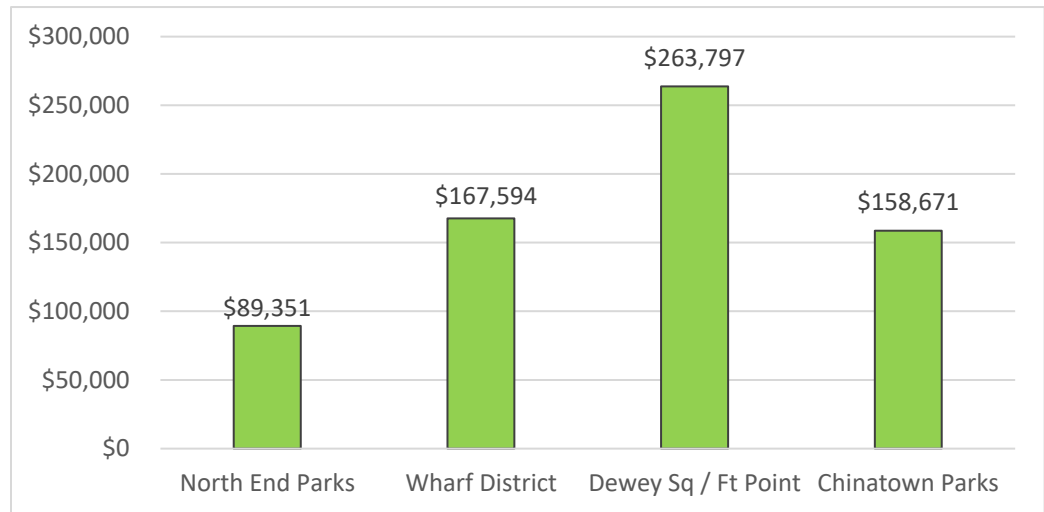
*Figure 2: Total Cost to Repair (by district)*

9. The VHB Team’s cost estimate for all observed physical deficiencies is approximately \$679,000, including all park and fountain assets. The majority of this amount (approximately \$491,000) can be attributed to paver repair needs. The breakdown of this cost estimate by district can be seen in Figure 2. Specific cost estimates are provided within the GIS Asset Inventory tool.

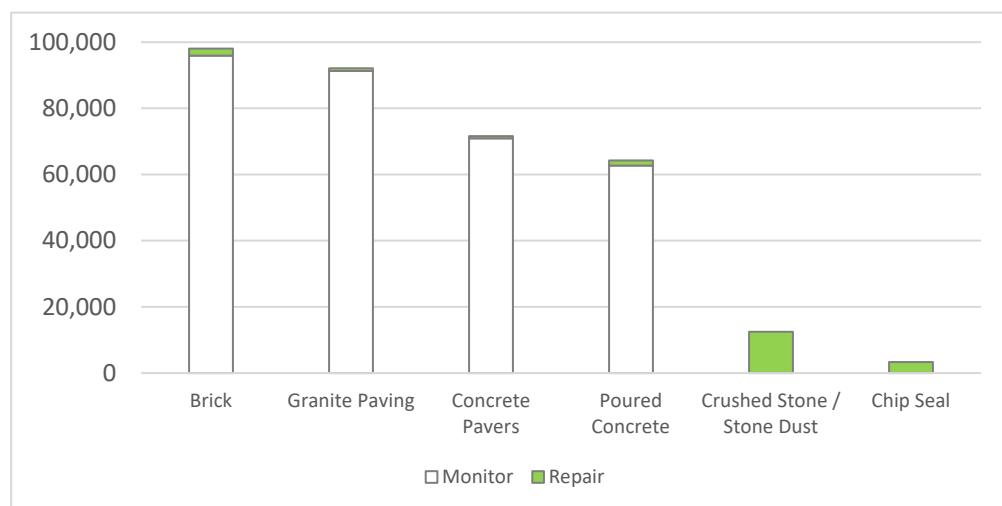
*Figure 3: Pavers – Recommended Repairs (SF)*

**Dry Set Paving.** Dry Set Paving types include the Mothers' Walk Engraved Concrete Pavers, Concrete Pavers, and Brick. All of these paving types are generally in good condition with no observed failing edges, differential settling, or major heaving from tree roots. Some minor heaving of the large concrete pavers was noted in parcel 14 near the carousel. Continue repairing localized issues caused by settling, vehicle damage, and tree root heaving.

**Ground Plane Granite.** Granite paving throughout the Greenway is in very good condition. Some grout joints have minor chips and loss that are typical of wet-laid paving. Continue monitoring and repairing localized grout issues or other cracked or damaged paver areas as needed.

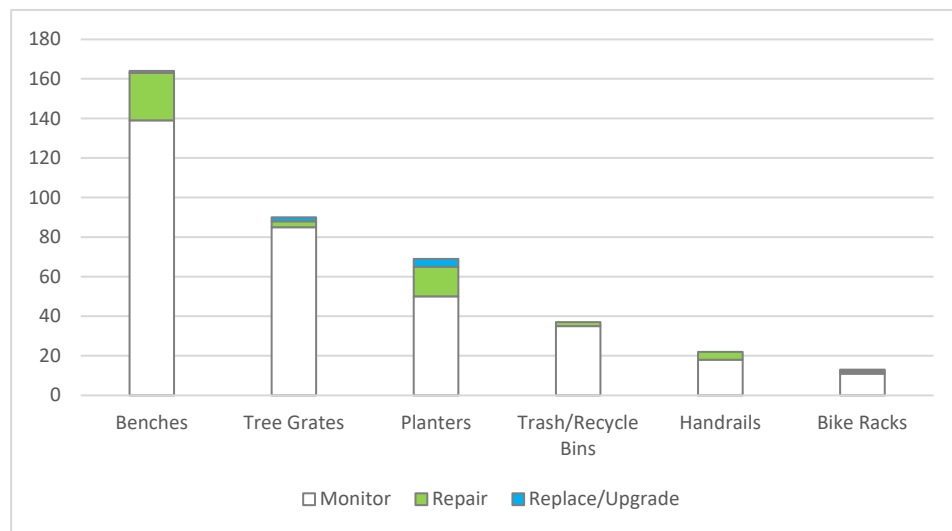
*Figure 5: Fixed Furniture – Recommended Actions*

**Benches (with and without wood).** Benches throughout the Greenway are mostly in good condition. The Primary concern regarding bench damage is localized powdercoat failures along bench undersides and points of ground contact. Monitoring and maintenance of these areas will prolong bench life. Utilize manufacturer provided touch-up kits or off-the-shelf repair paint materials as needed. Remove visible rust prior to applying finish repair coats. Consider shimming up bench feet in failure-prone areas to minimize ground water contact and limit premature failures. Most of the benches with wood slats are beginning to show aging. Bench slats appear to be in fair condition, however, slat replacement should be considered within the next several years. Continue to monitor slat condition and replace as needed.

**Tree Grates.** Tree grates are prevalent throughout the Greenway and most are in good condition. Many grates are showing some surface finish failures, but this is a common occurrence that should not greatly diminish service life. Several grates were noted as cracked, likely due to vehicle traffic (note: Greenway tree grates are not rated for vehicular

**Tables and Chairs.** The Landscape Forms Parc Center table and chairs located in Mary Soo Hoo Park are in fair condition with significant surface damage on many of the table tops. These furnishings are structurally sound but should be considered for replacement (or refinishing) in the next several years due to the finish condition.

**Railing.** Generally in good condition, some chipped-up areas near base of support legs, but nothing major. Skateboard damage can be seen on many sections of railing, but this damage is limited to the finish and all railings are structurally sound.

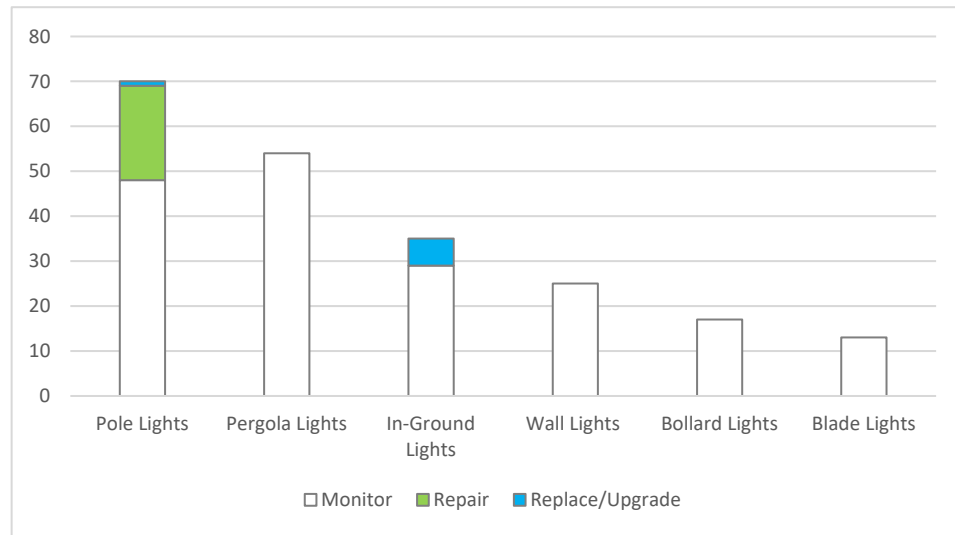
*Figure 7: Lighting – Recommended Actions*

**In-ground Uplights.** Most in-ground light fixtures are in fair to good condition. Many of the larger in-ground fixtures as the southern end of the Greenway show finish damage on the housings and many fixtures have evidence of moisture within the housing. Damaged finish on housings may be refinished with off-the-shelf repair paint and moisture within fixtures should be remedied by checking and replacing housing seals as needed. Stainless steel in-ground lights elements all appear to be in good condition with no visible issues.

**Pole Lights.** Several types of pole lights are present throughout the Greenway. Pole lights at the southern end of the Greenway are in good condition with no consistent finish issues aside from occasionally missing outlet covers and minor finish damage near pole bases. Pole lights located near the mid-point of the Greenway are generally in good condition. Peeling finish coating can be found at the base of many poles of this type. Touch-up painting should be considered at the base of all poles. Pole lights located at the northern end of the Greenway are generally in good/fair condition. The powdercoat finish on this particular light pole is beginning to fade and refinishing of these poles should be considered in the near future.

**Outlets.** Outlets can be found throughout the Greenway either integrated into light pole bases or as standalone outlet pedestals. Some access panels on poles have been damaged or removed. Several outlets were tested and were in working order.

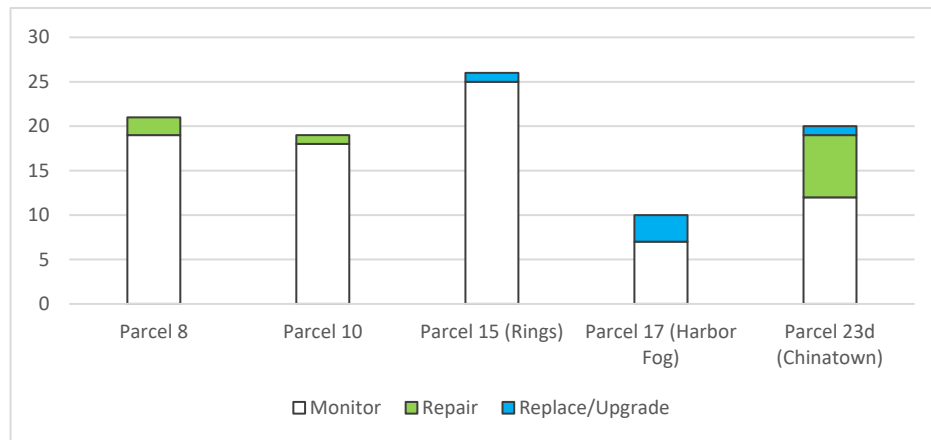
*Figure 9: Fountain Components – Recommended Actions (by Fountain)*

The Greenway Conservancy owns, operates, and maintains five fountains located along the Greenway in Boston, MA. Weston & Sampson Engineering, Inc. (WSE) evaluated assets associated with each of these fountains. Each condition assessment was entered into Survey123 which linked the assessment to the asset point within ArcGIS. The condition assessment was conducted on Tuesday, June 9, 2020. All fountains were operational during the site inspection except for the North Canal Fountain which was being repaired at the time. The following summarizes the findings from the assessment.
