The Rose Kennedy Greenway

Climate Change Vulnerability Assessment & Asset Management Plan

December 31, 2020

Prepared by Kleinfelder Northeast, Inc.
One Beacon Street, Boston, MA

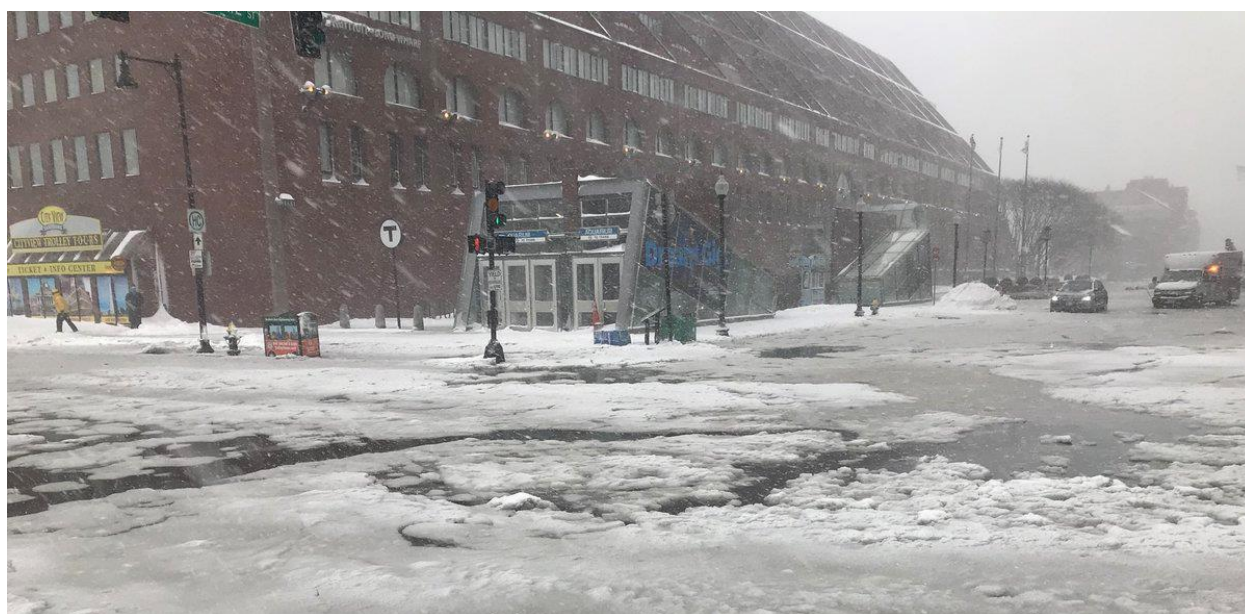
Figure 1 Flooding at MBTA Aquarium Station, January 2018 (Source: Rose Kennedy Greenway Twitter)

The BH-FRM became publicly available in 2015, which prompted the City of Boston to undertake its Climate Ready Boston planning efforts beginning in 2016. In 2018, the MBTA experienced damage at the Aquarium Station East Headhouse on Long Wharf during two major coastal flooding events. The MBTA has since undertaken a project to protect the station from overland coastal flooding using a deployable flood barrier system. In 2020, the City released a neighborhood plan to specifically identify actions to minimize damage from coastal flooding in the Downtown and North End neighborhoods. The plan's concluded action is a district-scale infrastructure project to block flood pathways at the harbor edge to provide flood protection for 100-year flood events in 2070. The massive undertaking will likely take many years to complete and cost billions of dollars. Climate change was 'made real' by the impacts of the flooding in 2018, and it became apparent that these events would become increasingly common, jeopardizing Boston's building stock, historic landmarks, and public spaces in addition to putting the life safety of people at risk.

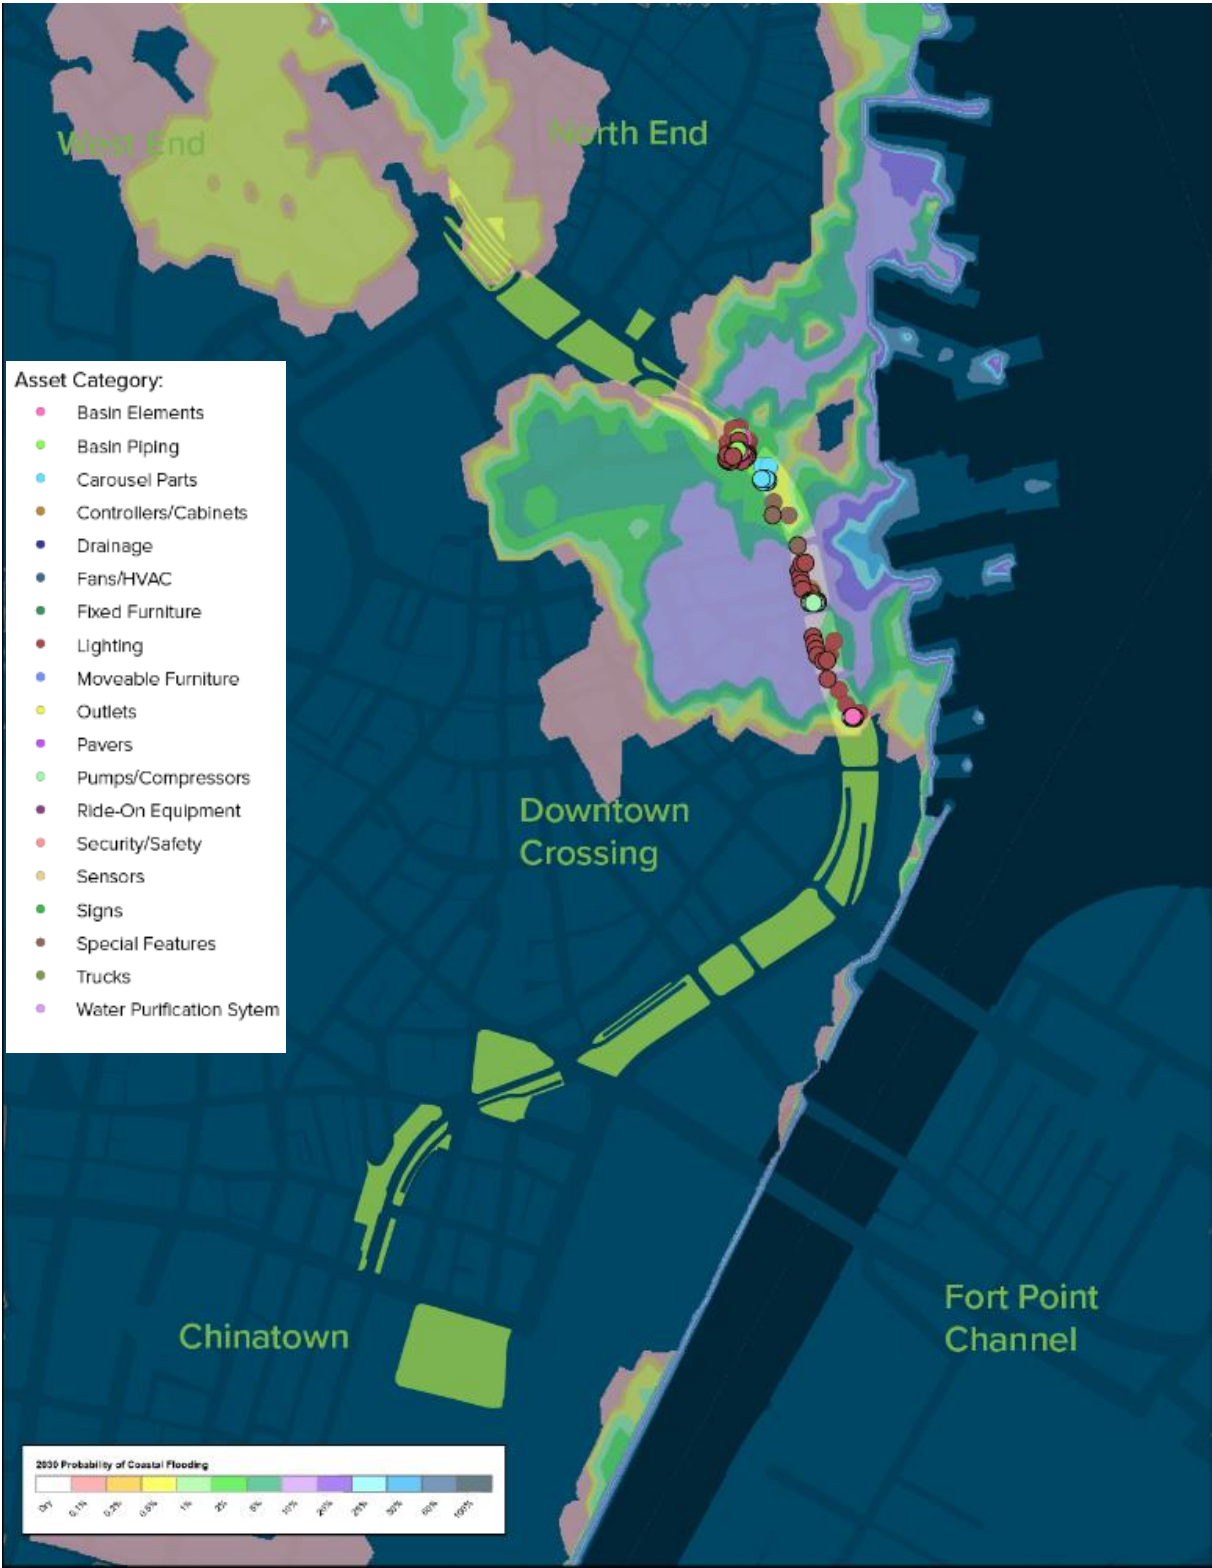
Figure 3 – Assets at Risk in 2030 from Coastal Flooding

During the 2030 timeframe, the overall risk to Greenway assets increases significantly. High-value assets are exposed to damaging levels of flooding in the 100-year event, including fountain systems stored in underground vaults, performance panels (electrical cabinets used to power equipment used for events), and the carousel. In addition, less valuable but similarly vulnerable assets are at risk, including light poles, furniture, trash receptacles, etc. The total replacement value of sensitive assets exposed in the 2030 100-year recurrence coastal flooding event is estimated to be \$3,953,394. It is important to note that the estimated replacement value of all assets is not the same as estimated damages - all exposed and sensitive assets would not necessarily require full replacement. In 2070 the replacement value jumps significantly to \$5,509,134 of the total replacement value portfolio of \$14,775,732.

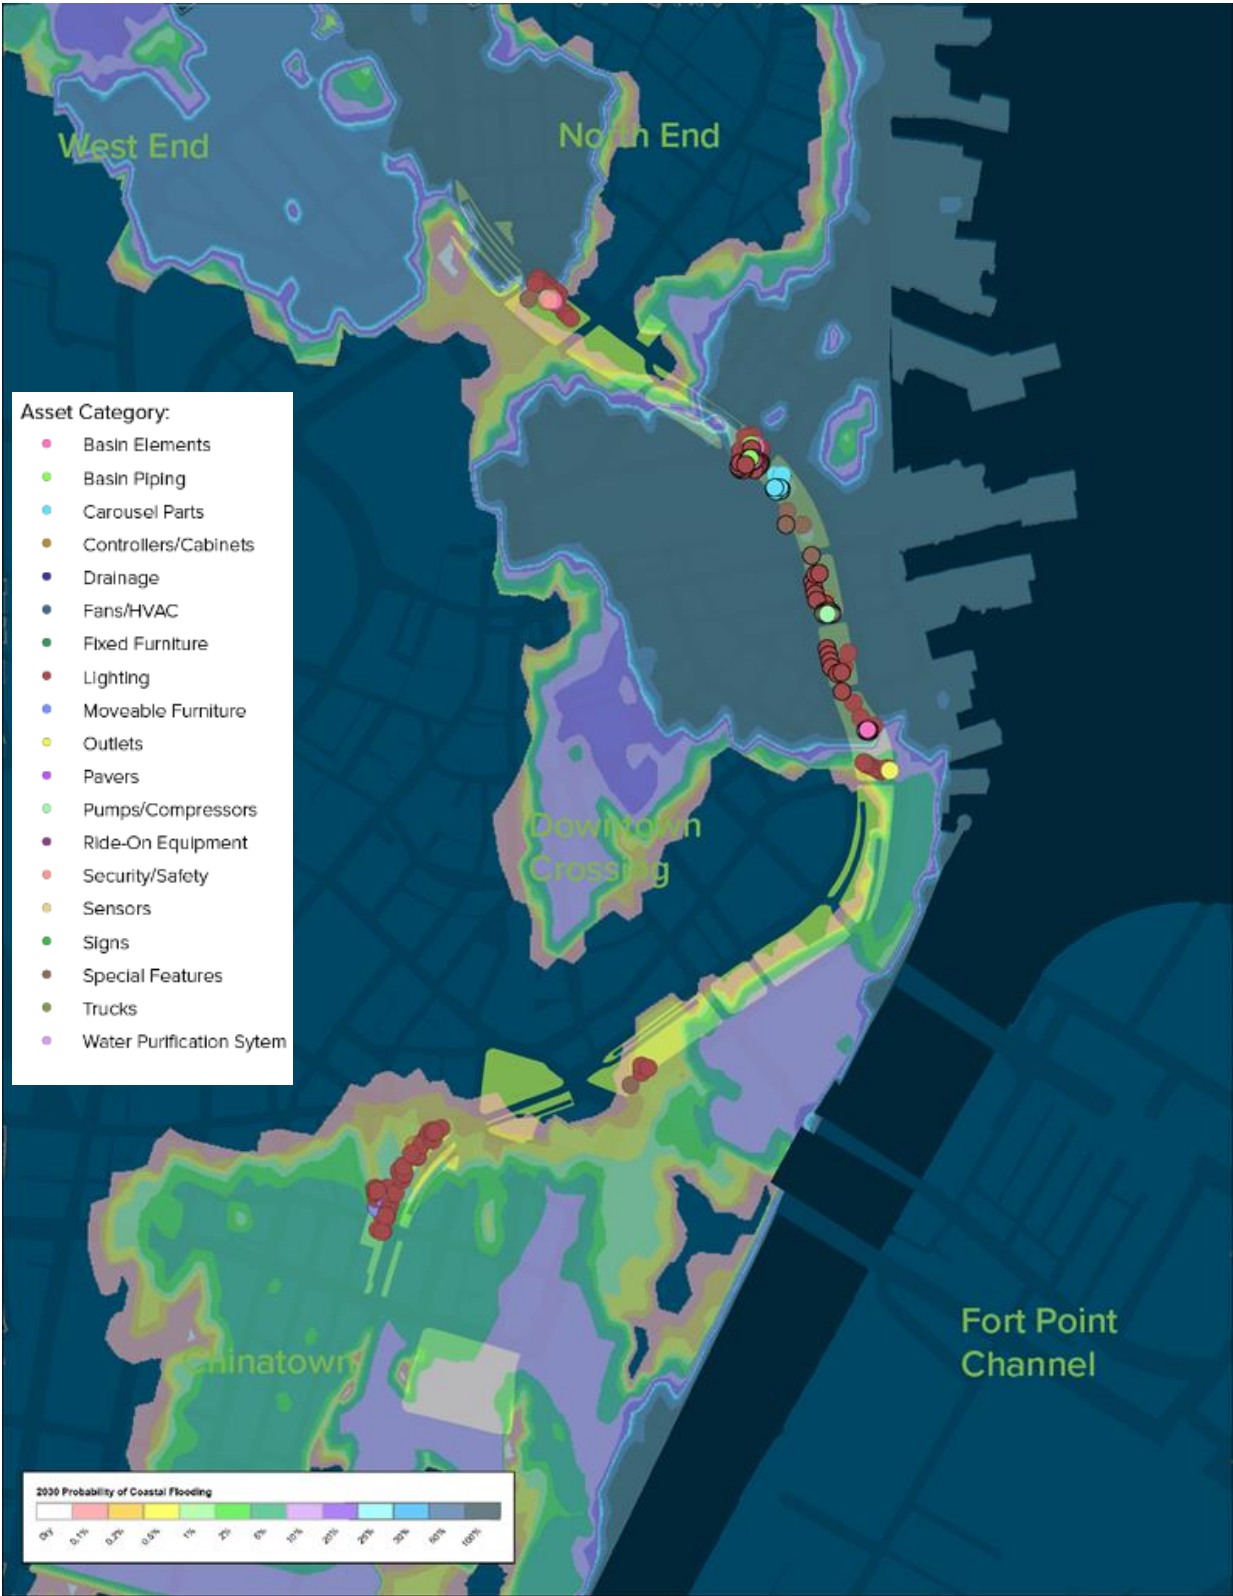
Figure 4 – Greenway Assets at Risk in 2070 from Coastal Flooding

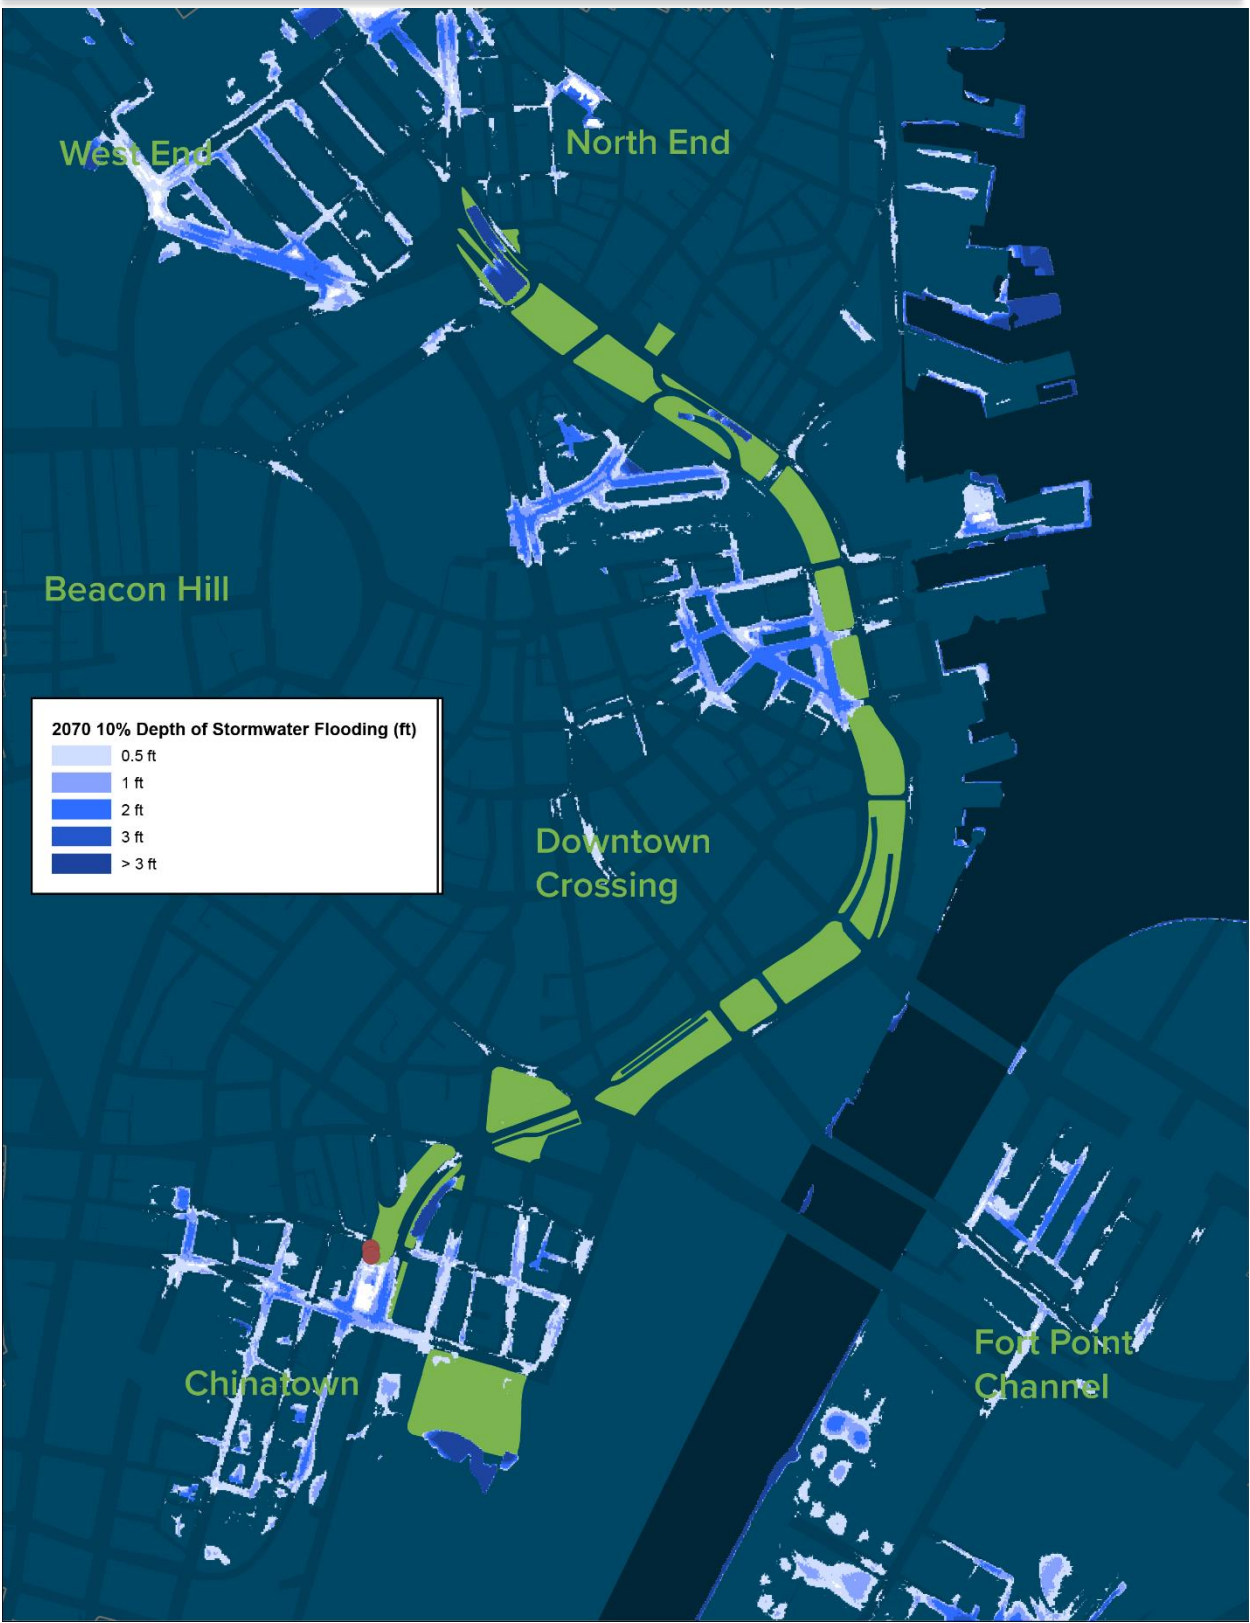
Figure 5 - Stormwater Flooding in 2070

As air temperatures rises, the air holds more water which leads to more intense precipitation events. Over time, extreme precipitation events will become more frequent and the City of Boston's drainage infrastructure will not be able to manage the amount of water, causing localized flooding. Assets at risk from a 10-year extreme precipitation flooding event in 2030 and 2070 are minimal. Currently, during a 10-year precipitation event, the Greenway experiences erosion of the crushed stone pathways due to runoff on the pathways. No additional assets were identified to be at risk during the 2030 and 2070 predicted extreme precipitation events.

Note that these findings are limited by the available scenarios. While coastal flood maps and data are available across a broad spectrum of probabilities, precipitation was only available for the 10-year storms. As additional scenarios become available from ongoing work at the Boston Water and Sewer Commission (BWSC), these findings should be revisited.
