The Rose Kennedy Greenway

Climate Change Vulnerability Assessment & Asset Management Plan

December 31, 2020

Prepared by Kleinfelder Northeast, Inc.
One Beacon Street, Boston, MA

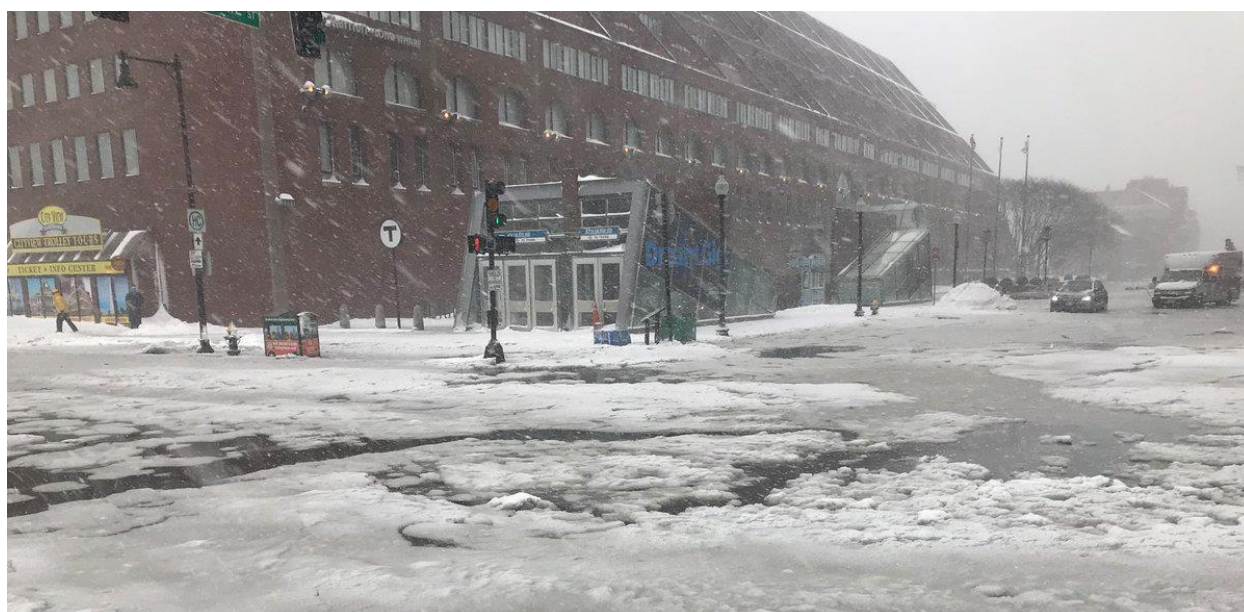
Figure 1 Flooding at MBTA Aquarium Station, January 2018 (Source: Rose Kennedy Greenway Twitter)

The BH-FRM became publicly available in 2015, which prompted the City of Boston to undertake its Climate Ready Boston planning efforts beginning in 2016. In 2018, the MBTA experienced damage at the Aquarium Station East Headhouse on Long Wharf during two major coastal flooding events. The MBTA has since undertaken a project to protect the station from overland coastal flooding using a deployable flood barrier system. In 2020, the City released a neighborhood plan to specifically identify actions to minimize damage from coastal flooding in the Downtown and North End neighborhoods. The plan's concluded action is a district-scale infrastructure project to block flood pathways at the harbor edge to provide flood protection for 100-year flood events in 2070. The massive undertaking will likely take many years to complete and cost billions of dollars. Climate change was 'made real' by the impacts of the flooding in 2018, and it became apparent that these events would become increasingly common, jeopardizing Boston's building stock, historic landmarks, and public spaces in addition to putting the life safety of people at risk.

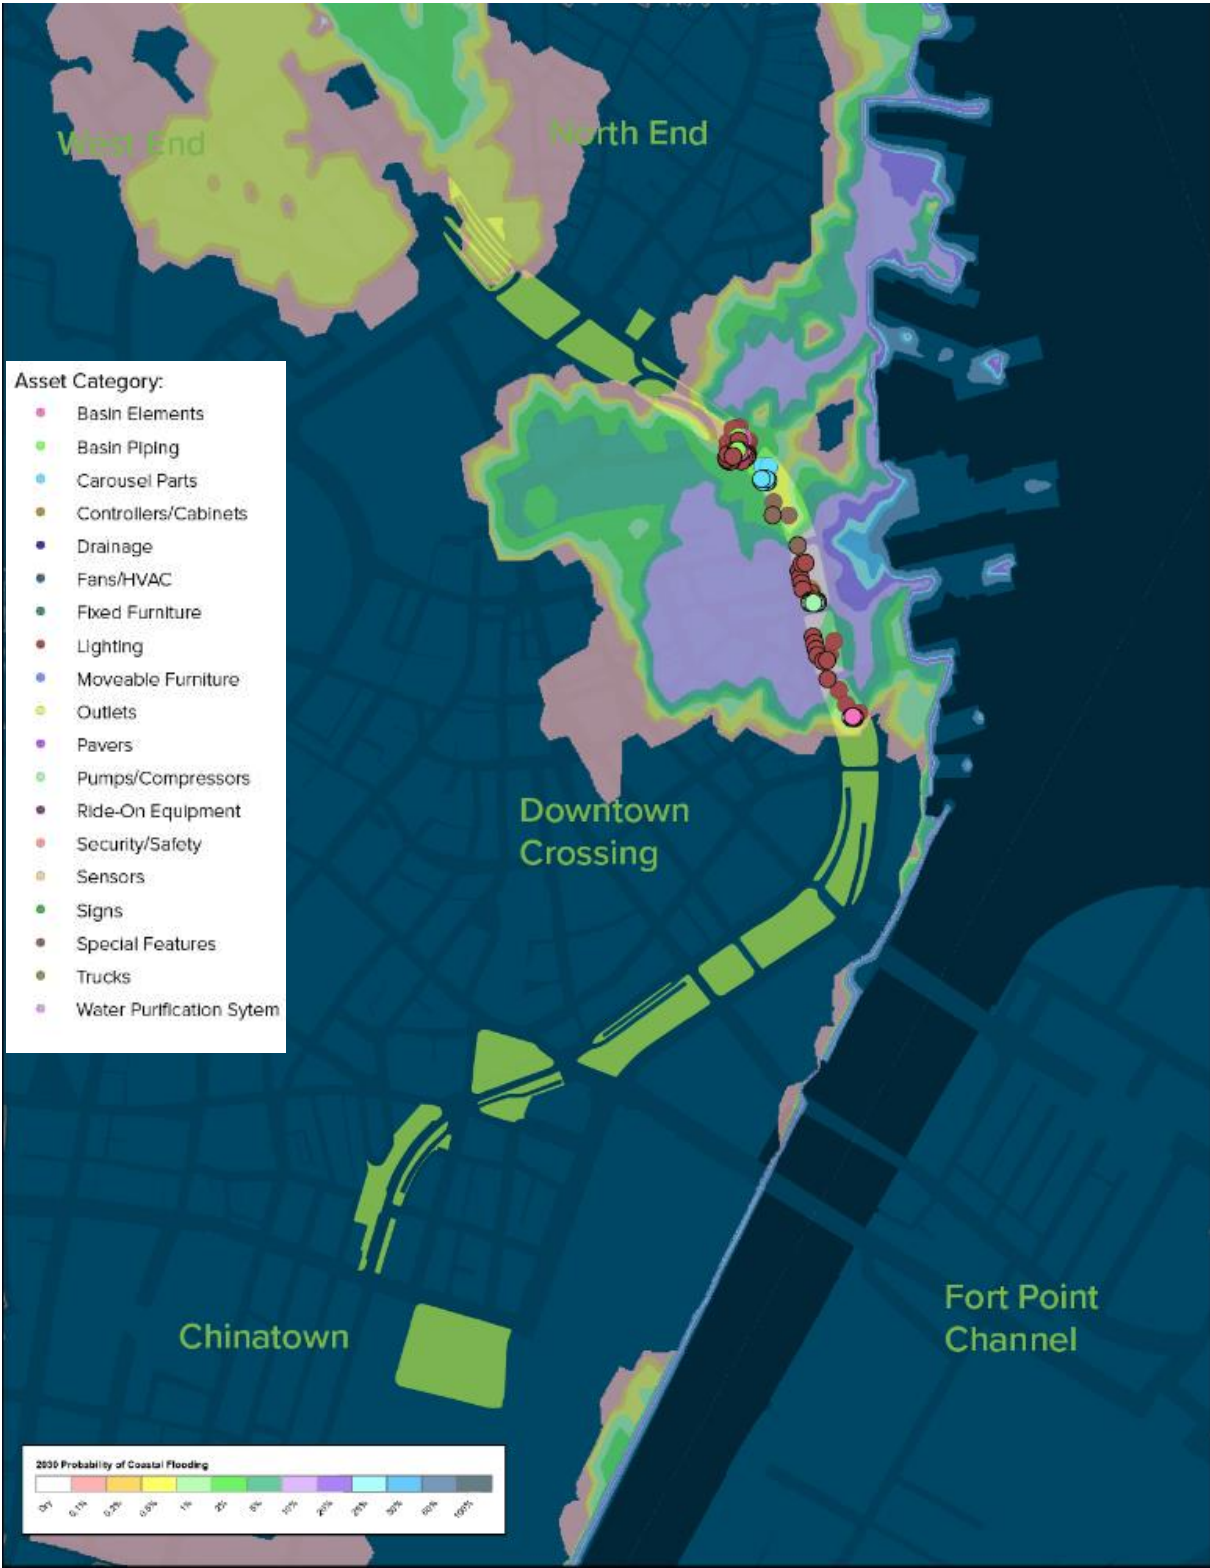
Figure 3 – Assets at Risk in 2030 from Coastal Flooding

During the 2030 timeframe, the overall risk to Greenway assets increases significantly. High-value assets are exposed to damaging levels of flooding in the 100-year event, including fountain systems stored in underground vaults, performance panels (electrical cabinets used to power equipment used for events), and the carousel. In addition, less valuable but similarly vulnerable assets are at risk, including light poles, furniture, trash receptacles, etc. The total replacement value of sensitive assets exposed in the 2030 100-year recurrence coastal flooding event is estimated to be \$3,953,394. It is important to note that the estimated replacement value of all assets is not the same as estimated damages - all exposed and sensitive assets would not necessarily require full replacement. In 2070 the replacement value jumps significantly to \$5,509,134 of the total replacement value portfolio of \$14,775,732.

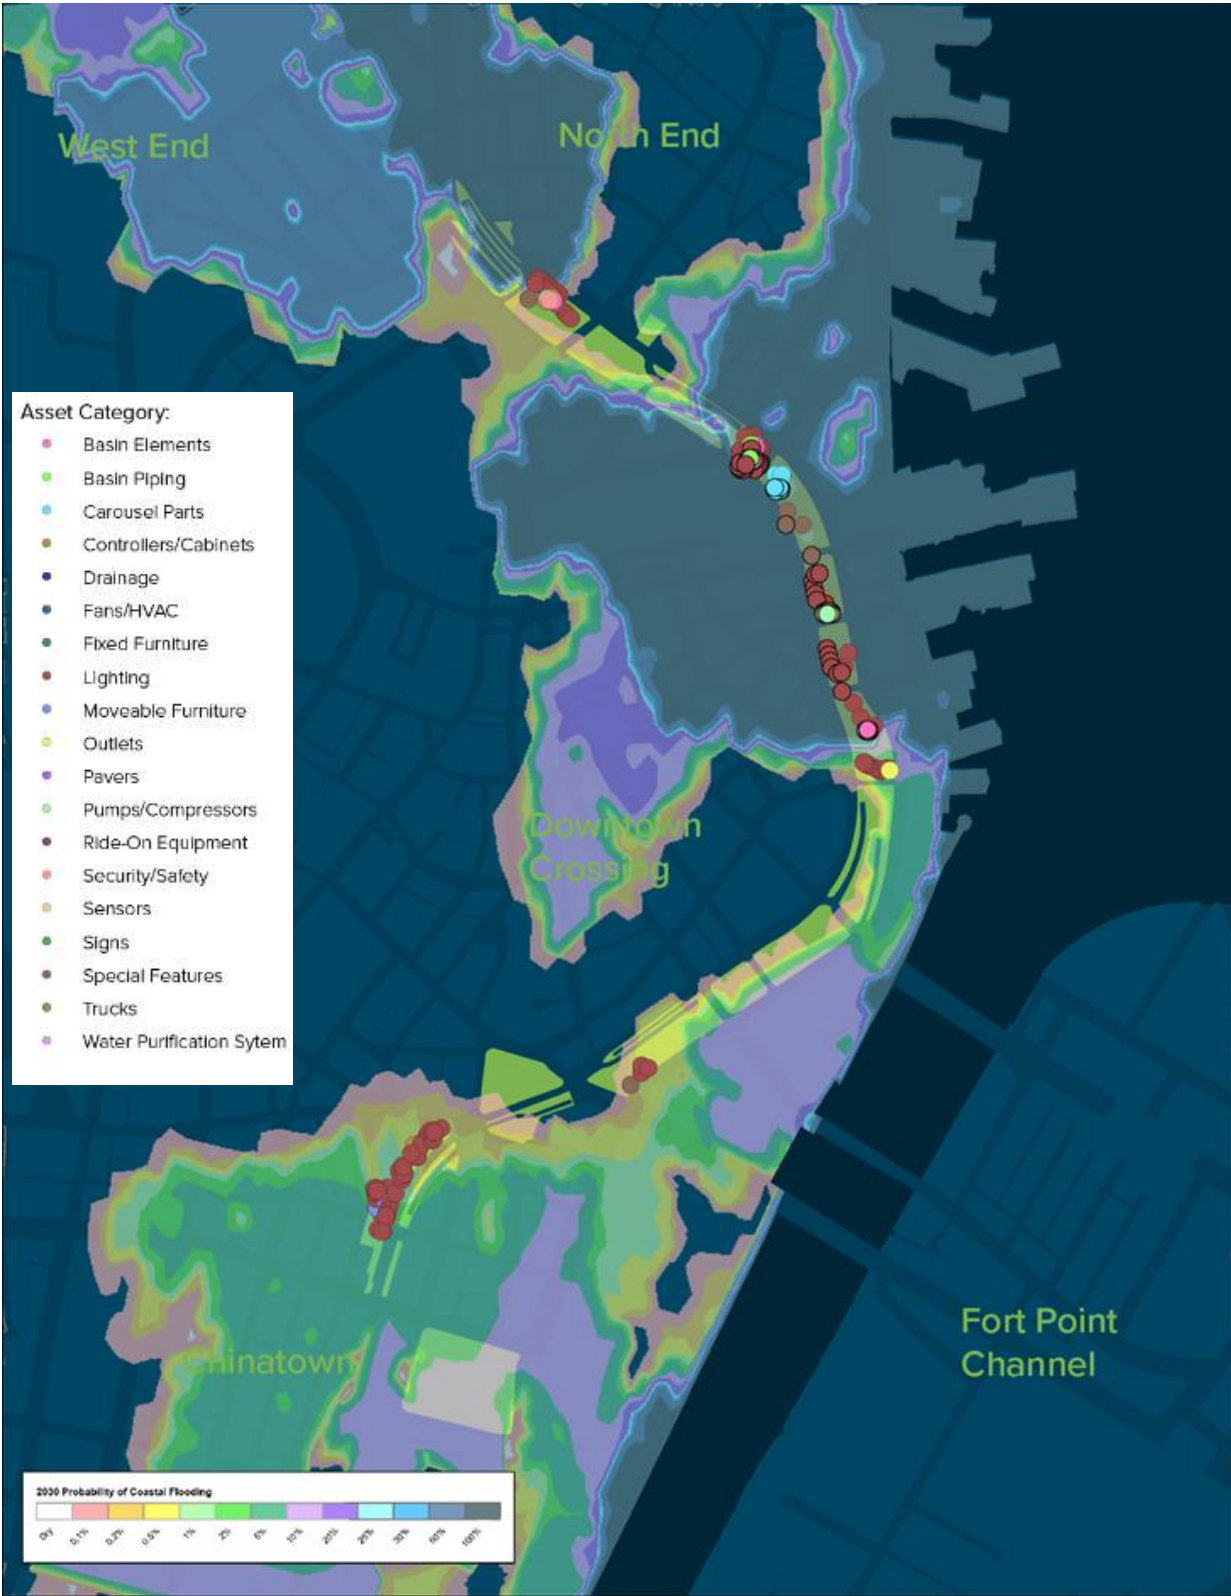
Figure 4 – Greenway Assets at Risk in 2070 from Coastal Flooding
